ENGINEERING DESIGN STATEMENT PREPARED BY TONKIN AND TAYLOR

Homeowners Wall - Coastal Erosion Protection

TOPOGRAPHICAL SURVEY OF
EXISTING REVETMENT STRUCTURE
BUFFALO BEACH ROAD, WHITIANGA

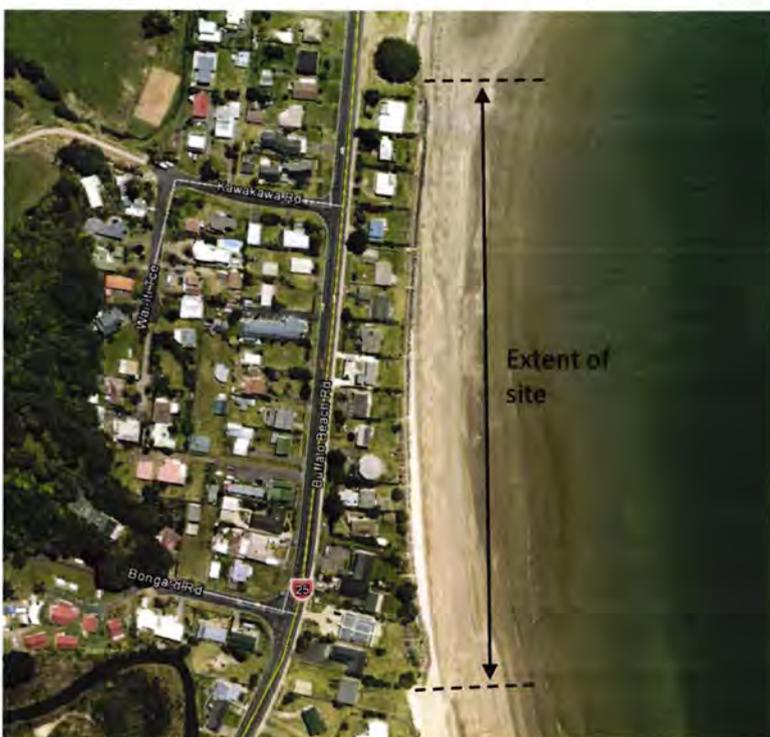
Figure 1-1: Site location plan

The site of the proposed coastal erosion protection structure is located at the northern end of Buffalo Beach. The site is bounded by Buffalo Beach Road/State Highway 25 to the west and the coastal marine area (CMA) to the east. Residential housing is located immediately landward of the site. Figure 1-1 provided below identifies the location of the proposed coastal erosion protection structure.

We understand that the proposed coastal erosion protection structure is around 360m in length.

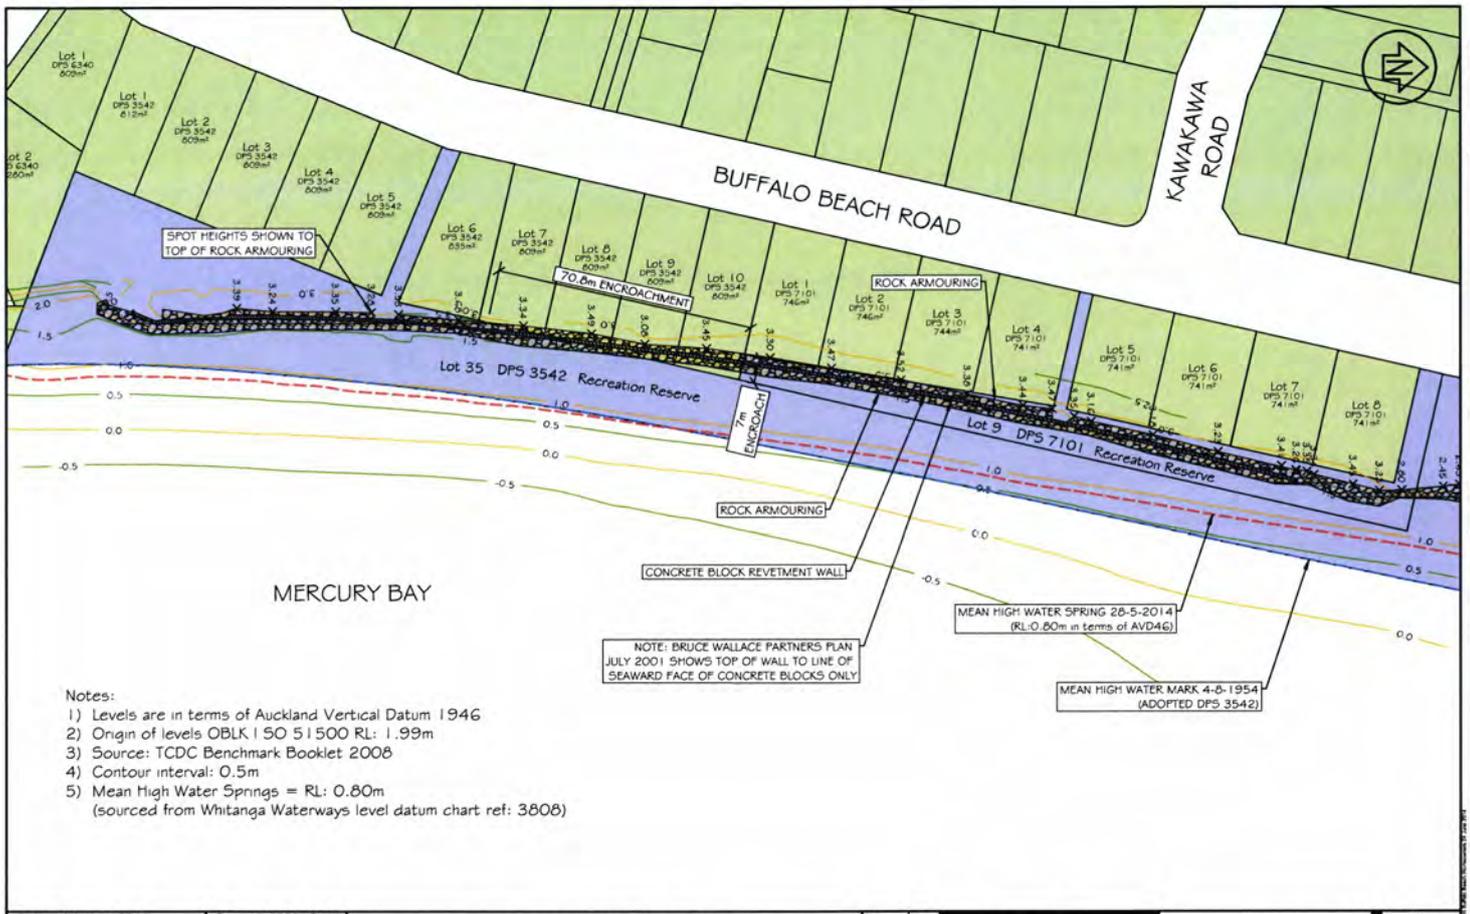
NOTE: BRUCE WALLACE PARTNERS PLAN JULY 2001 SHOWS TOP OF WALL TO LINE OF SEAWARD FACE OF CONCRETE BLOCKS ONLY

MEAN HIGH WATER SPRING 28-5-2014 (RL: 0.80m in terms of AVD46)

MEAN HIGH WATER MARK 4-8-1954 (ADOPTED DFS 3542)

The site is fronted by an existing rock riprap structure. The structure, along its length, is shown¹ to be predominately located within a Recreational Reserve (survey plan included in Appendix A), or straddling the seaward property boundary of the neighbouring residential area, through the central section. The structure extends into the neighbouring Macrocarpa Reserve, to the north, connecting to an existing structure administered by the Thames-Coromandel District Council.

Mean High Water Springs is shown on the survey plan to be seaward of the existing coastal protection structure, at the date of the survey.

The RMS survey (2014), shows the beach to the south of the seawall has eroded back to the point where the southern end of the seawall is exposed and is outflanked, with a risk of erosion behind the seawall. At the time of our July 2016 inspection, Council appeared to have recently completed beach dune regrading and planting in this area, and seawall outflanking was not evident to the extent indicated by the RMS survey.

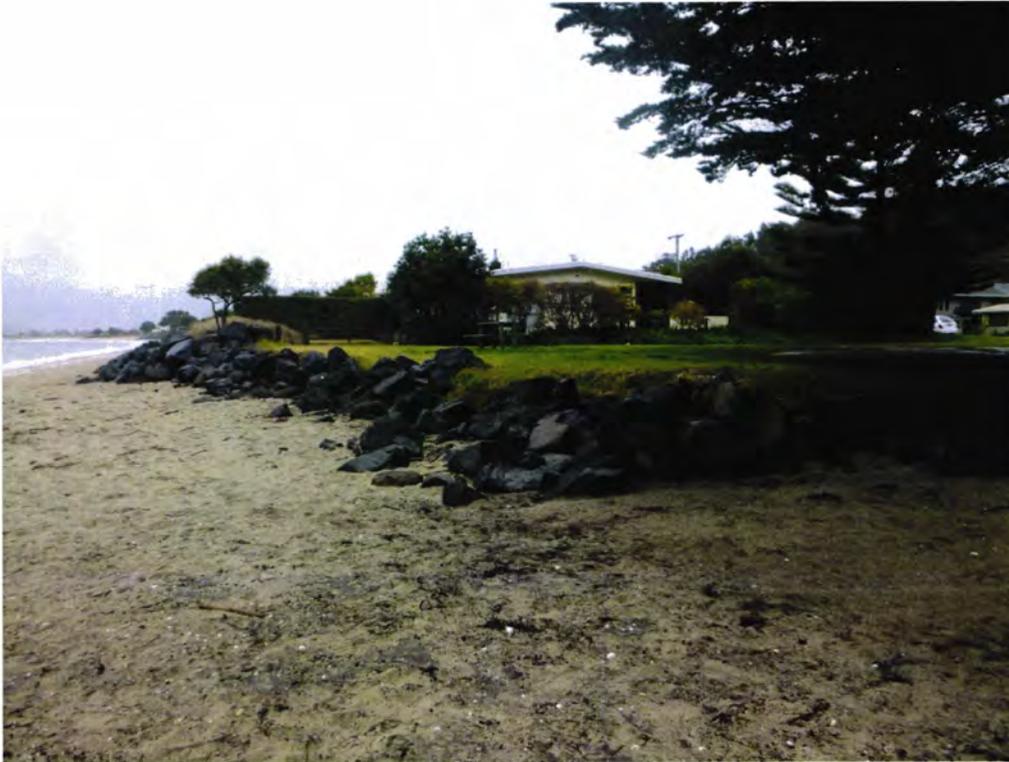
Photo 1: existing structure in Macrocarpa Reserve – administered by Thames-Coromandel District Council.

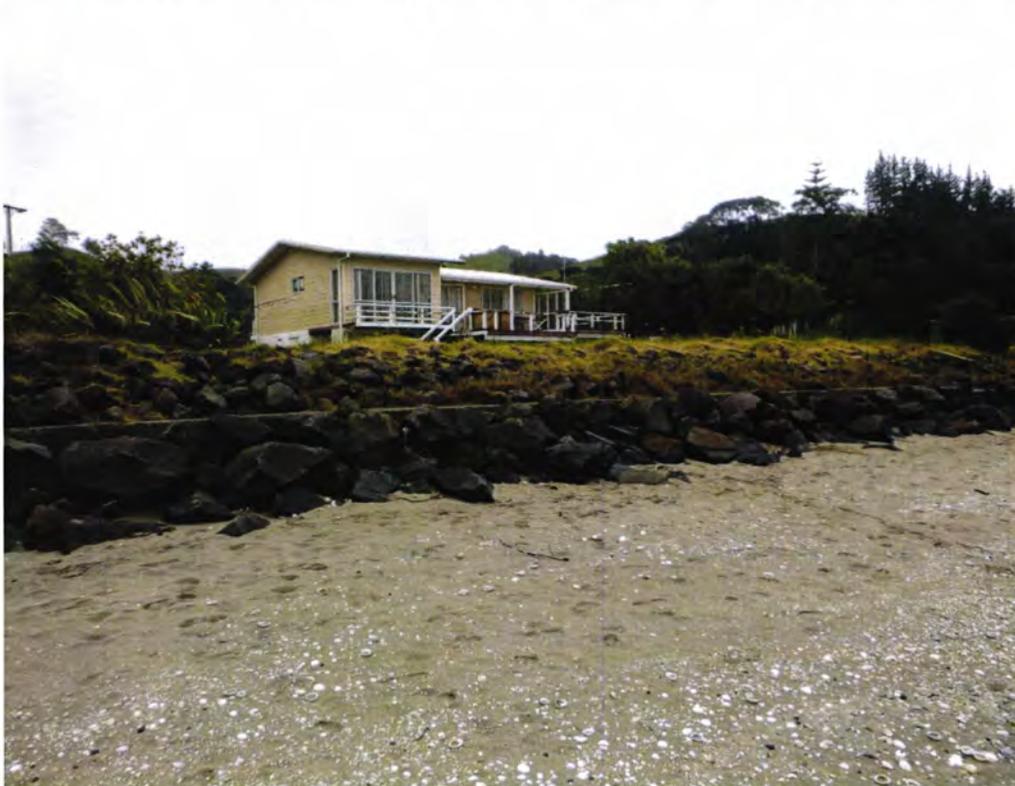
Photo 2: Typical profile for northern end of existing coastal protection structure

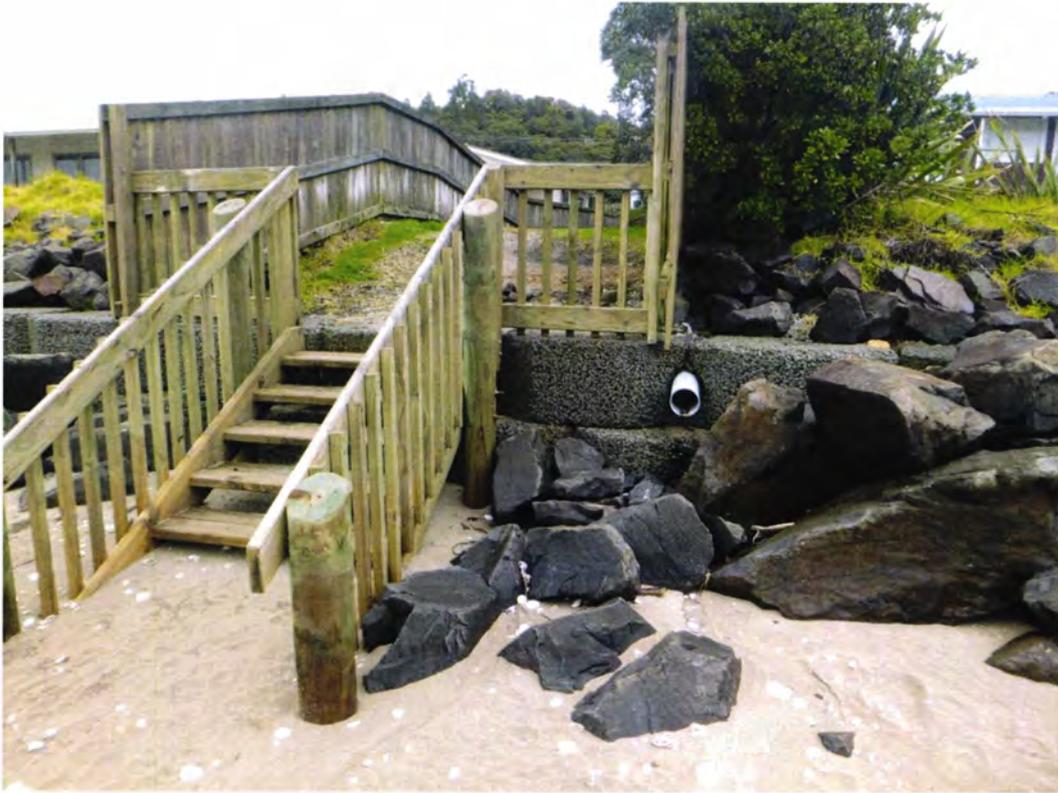
Photo 3: Existing public access structure

- **Access Structures:** a number of access structures exist along the length of the erosion protection works. These structures have been made from either concrete, timber or grouted rock.

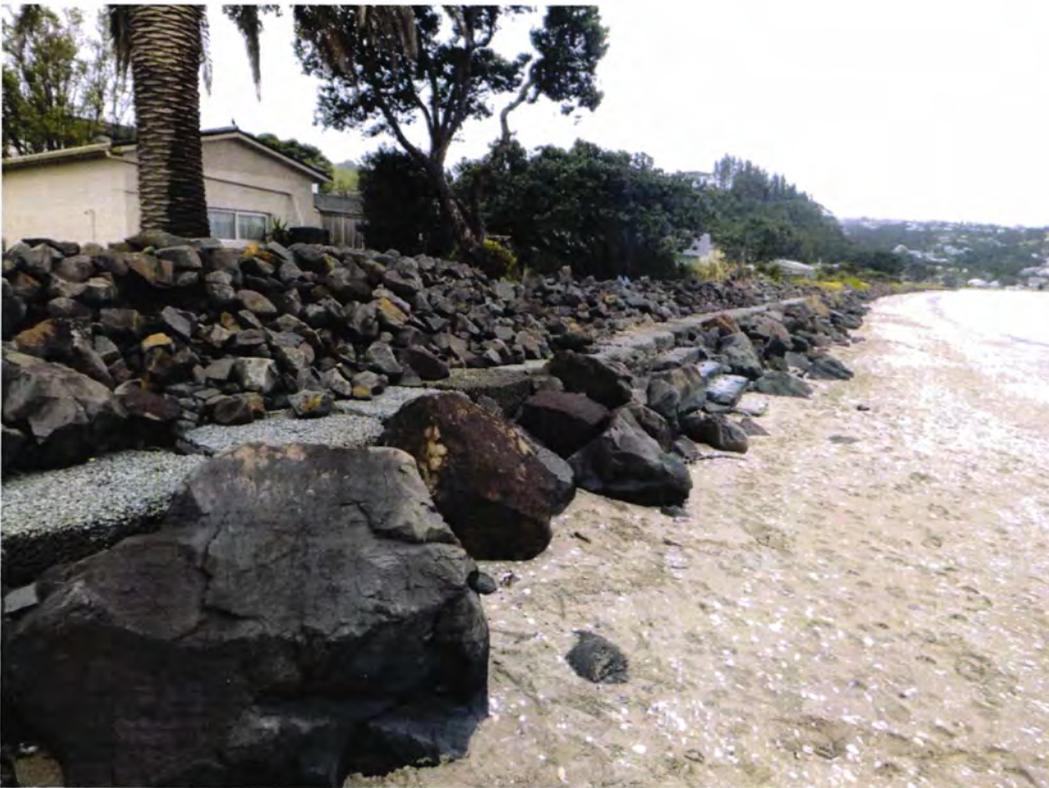
Photo 4: Typical section through central area.

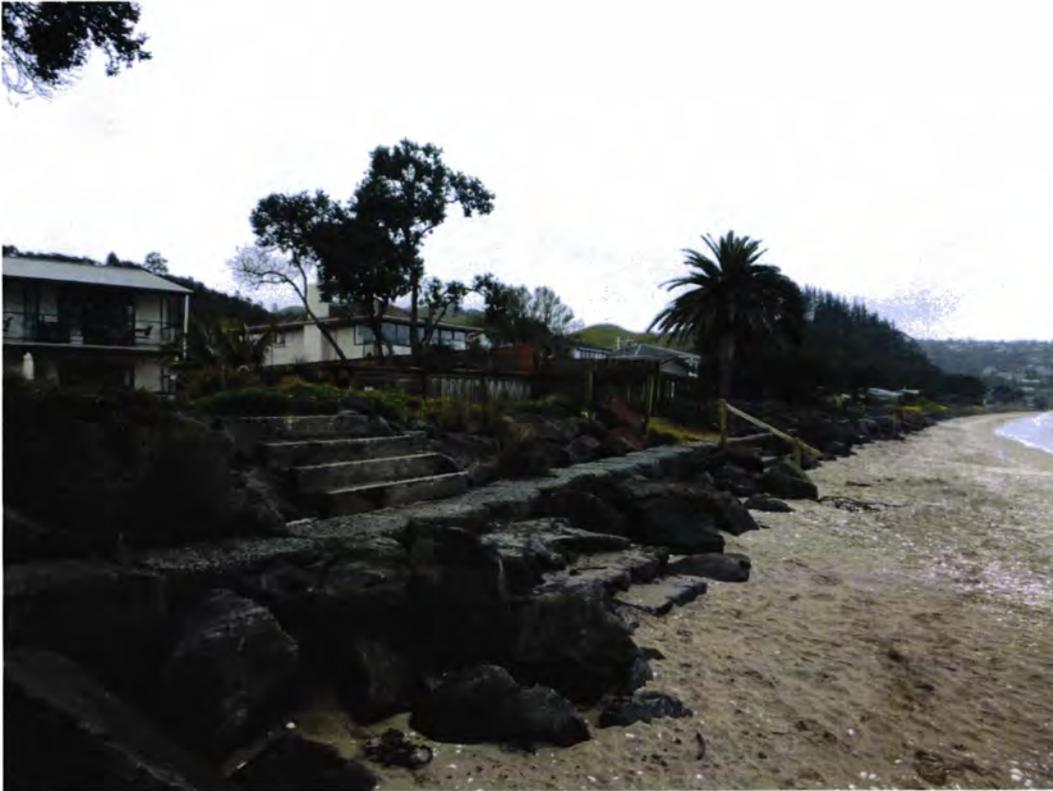
Photo 5: Typical section at southern end of the existing structure

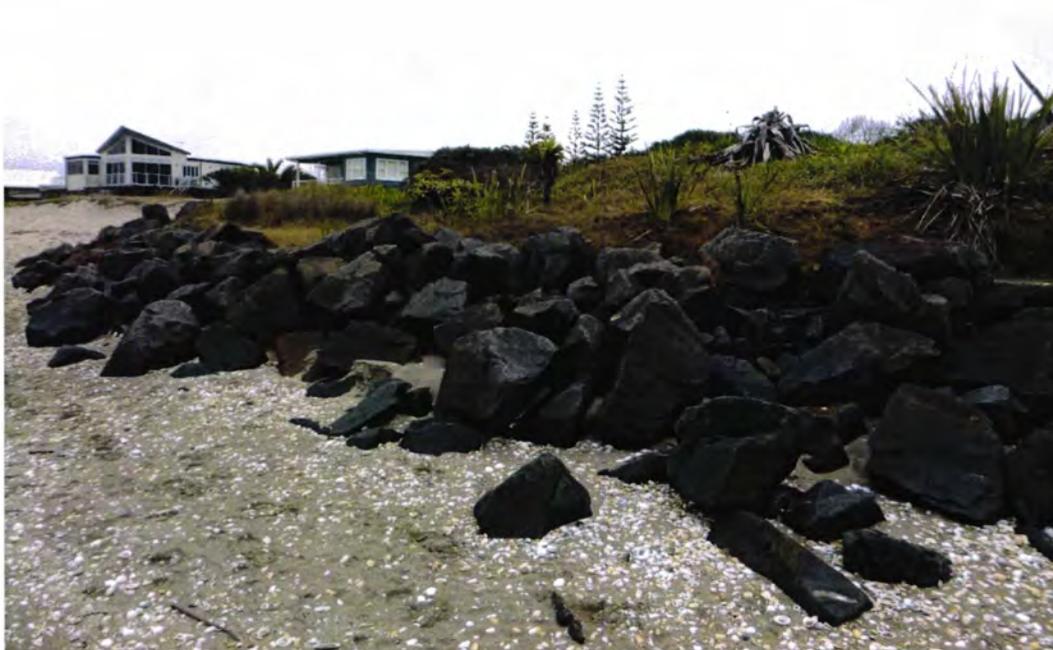
Photo 6: Southern extent of existing structure – showing landward retreat for unprotected area

In summary the existing coastal protection structure appears to be providing a reasonable level of protection to the backing land when compared to adjacent areas that do not have a protection structure. As a result the beach width fronting the structure is reduced compared to adjacent land area to the south where the beach has migrated inland (refer Figure 1).

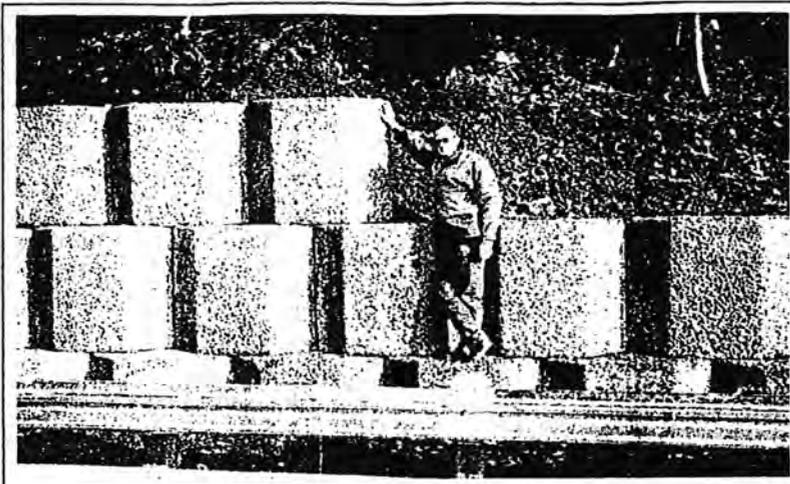
The *MassBloc™* (pat. approved) is a manufactured permeable concrete block, precast in a variety of sizes and colours. Blocks in place have the ability to interlock using the lip cast into the base of each standard unit. This

interlock area extends from the rear surface by a distance of 150 millimetres and serves to lock the block to blocks placed below. The rough exposed concrete surfaces of the block aid the resistance to shearing forces by increasing the friction between units.

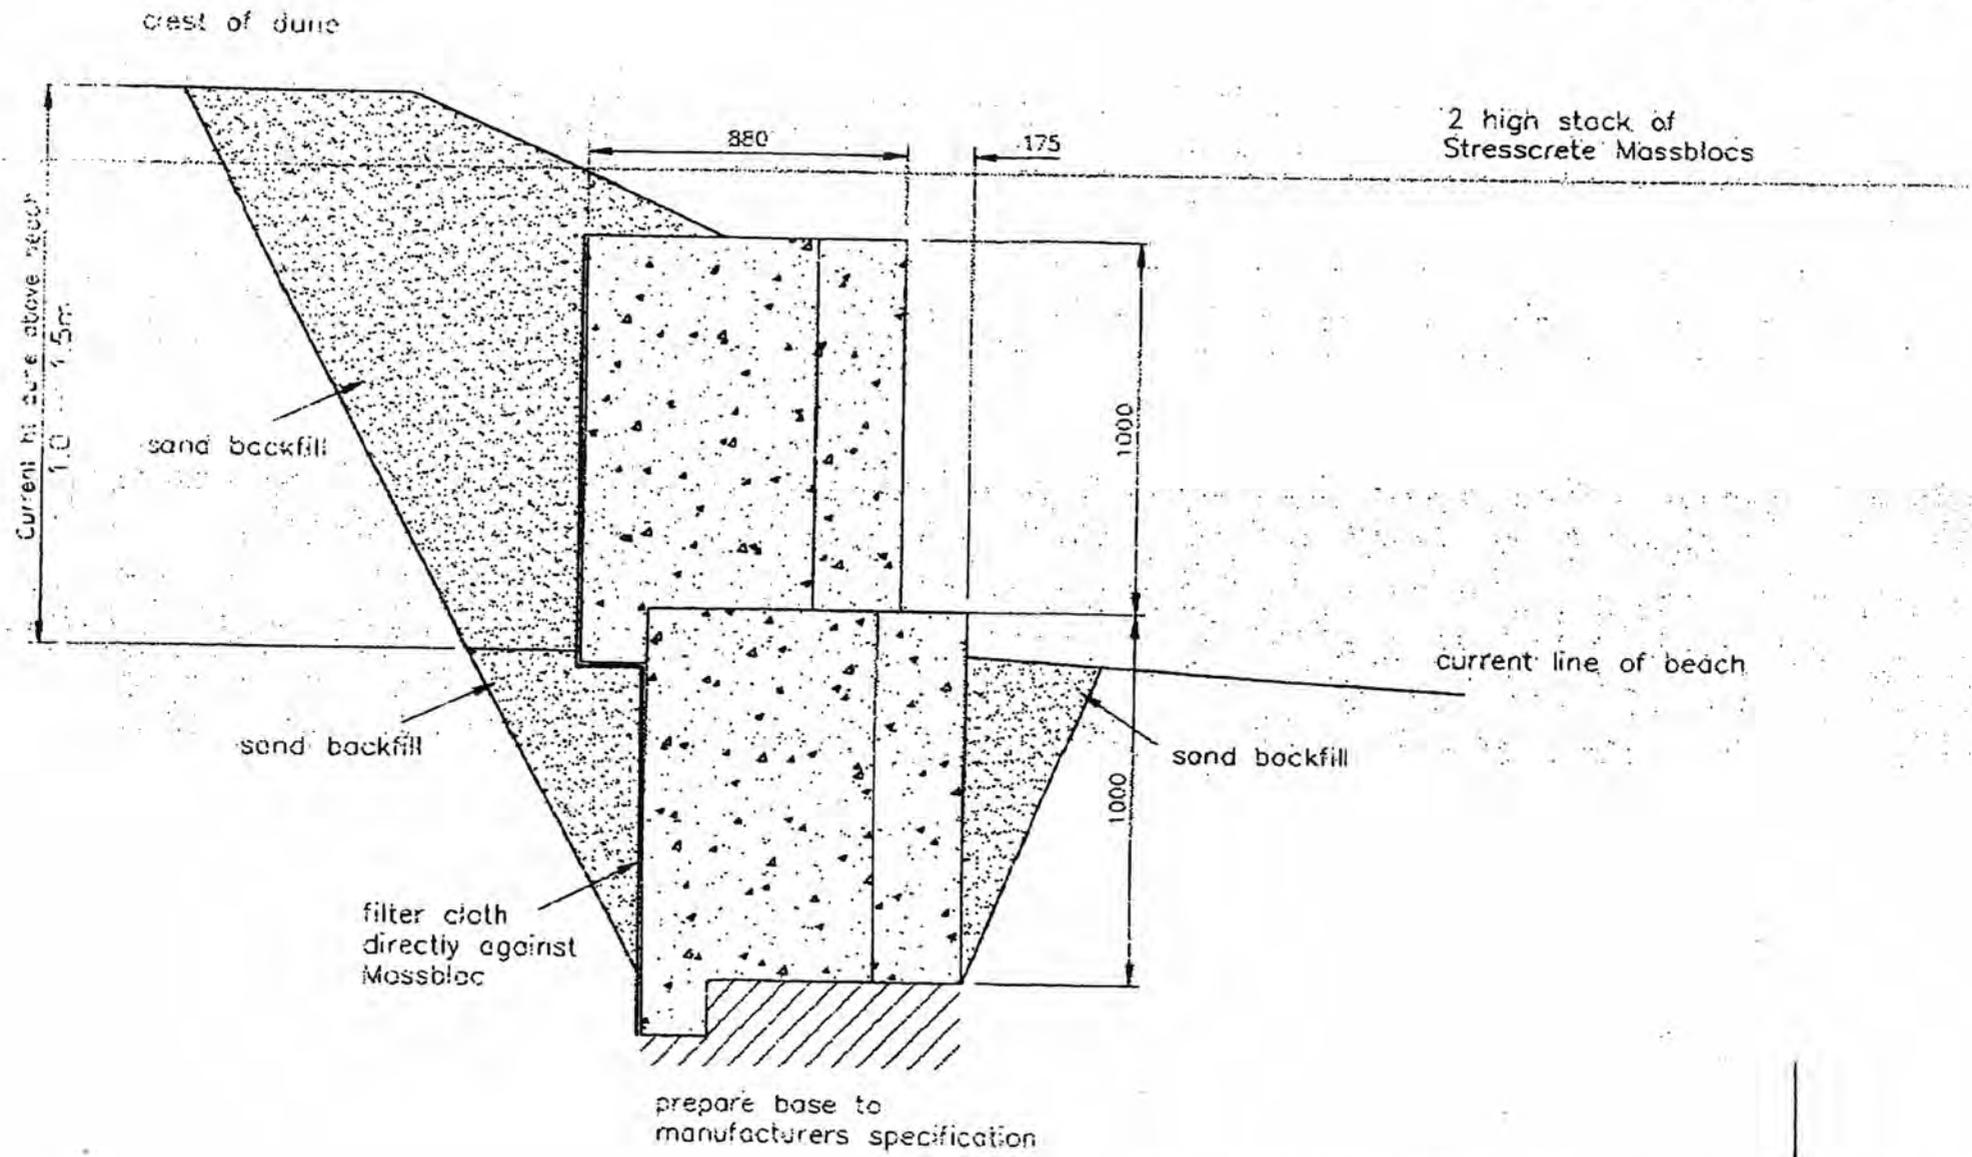
Typical section through sea-wall
 Area D, Buffalo Beach

Designed & drawn A4 SIZE at 1:20 scale by B.F. Boult

As discussed above, information on the existing seawall construction was provided to T+T at our March site meeting by the Homeowners representatives. Details of the existing seawall are attached in Appendix C, and include B. F. Bolt and Associates drawings of the Massbloc wall, together with a series of 12 photos taken during the wall construction. Key details of the construction include the following:

- The Massbloc wall is a minimum 2 units high, however in the central and northern section where the beach was lowest, this height was increased to 2.5 units high. This is shown in the photos and the half units were observed in our recent site inspection. Based on this evidence we believe the Massbloc wall is 2.5m high in the central and northern sections, and 2m high for the southern section.
- The seawall survey (refer Appendix A), surveyed the top of the Massblocs generally at an elevation of +2.5m AVD-46 (Auckland Vertical Datum 1946). This implies that the toe of the Massbloc units are at RL 0.0m AVD-46 for the central and northern sections of the wall, and at +0.5m AVD-46 for the southern section of the wall.

- The design drawings and the construction photos both show a geotextile behind the wall and extending up above the height of the Massbloccs to close to the elevation of the ground above the Massbloccs.

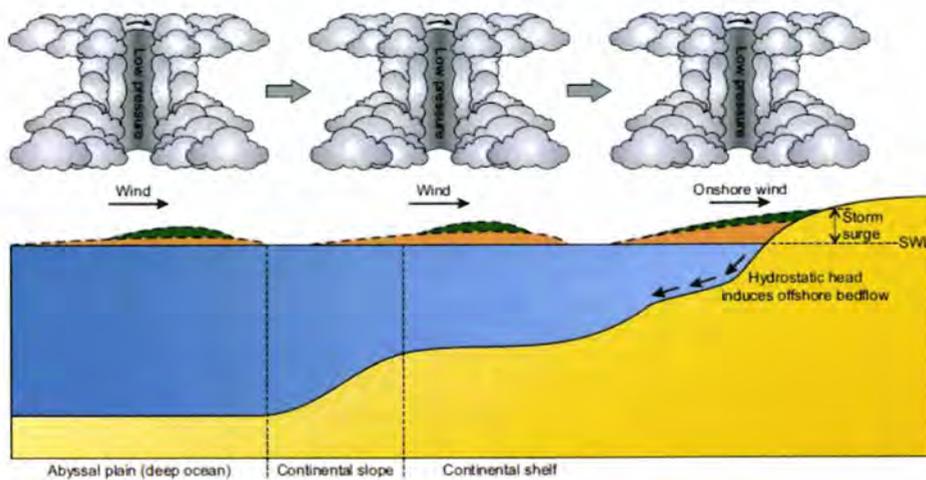
Figure 1-1 Processes causing storm surge (source: Shand, 2010)

Storm surge, results from the combination of barometric setup from low atmospheric pressure and wind stress from winds blowing along or onshore, which elevate the water level above the predicted tide (Figure 1-1). The combined elevation of the predicted tide and storm surge is known as the storm tide. Storm tide estimates for Whitianga were derived by performing a Monte Carlo simulation using recorded annual maximum sea levels provided by NIWA (Figure 1-2). These storm tide values including astronomical tide, storm surge and fluctuations in mean sea level are shown in Table 1-2 with respect to mean sea level at Whitianga and AVD-46. Consideration of a 1% AEP event for assessment of coastal flooding is considered industry best practice (Ramsey et al., 2013). There is a 39.3% chance of such an event being exceeded over the next 50 years and 63.2% chance over the next 100 years.

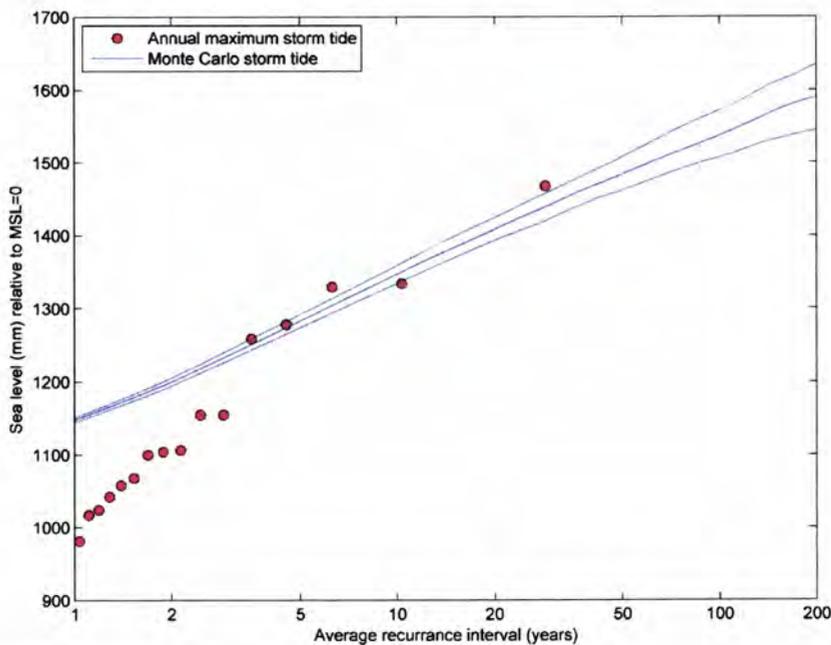
Figure 1-2 Storm tide for Whitianga (source: NIWA, 2014)

AEP (Annual Exceedance Probability)	Average Recurrence Interval (ARI)	MSL (m)	AVD46 (m)
50%	2 year	1.2	1.3
20%	5 year	1.29	1.39
10%	10 year	1.35	1.45
5%	20 year	1.41	1.51
2%	50 year	1.49	1.59
1%	100 year	1.54	1.64

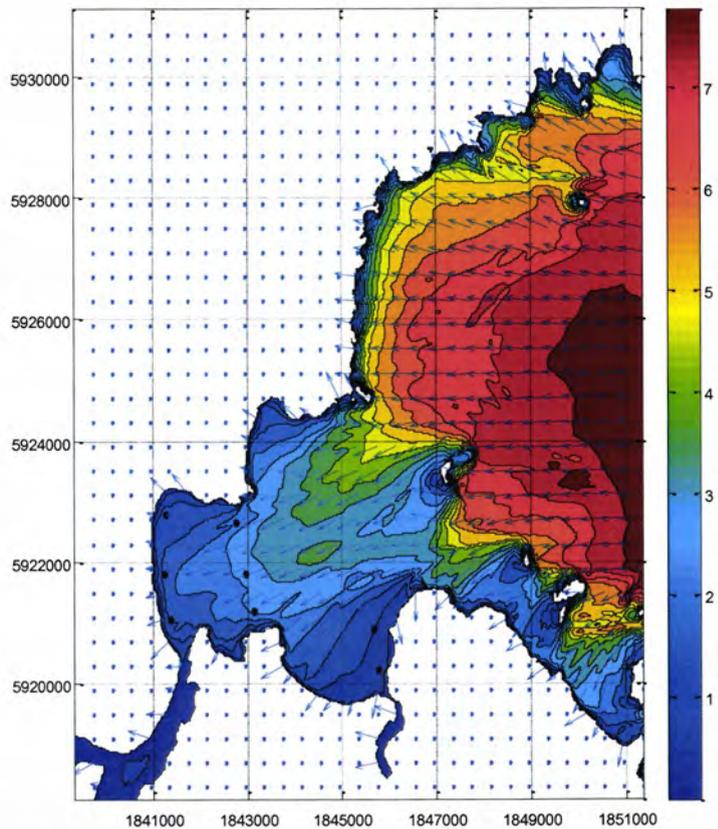
Figure 1-3 SWAN output for Mercury Bay for a 100 year ARI event from the East.

Numerical wave transformation modelling has been undertaken to determine likely wave conditions offshore of Whitianga Beach that may elevate water levels due to wave setup. SWAN (Simulating WAVes Nearshore) is a third-generation wave model that computes random, short-crested wind-generated waves in coastal regions and inland waters. SWAN was developed at Delft University of Technology in the Netherlands and is widely used by government authorities, research institutes and consultants worldwide. Further details of SWAN can be found in Booij *et al.* (1999).

The model domain was constructed using bathymetry sourced from the LINZ Nautical Charts. Bathymetry maps of the central eastern part of the Coromandel peninsula (regional grid) and Mercury Bay, including Buffalo Beach (nested grid), have been generated. A 1% AEP significant wave height of 7.1 m and peak period of 11 seconds has been adopted as model boundary conditions based on wave data analysis by NIWA offshore of Mercury Bay. Winds are based on the yearly 1 hour wind speed from AS/NZS 1170.2:2011. Winds and waves from the north to southeast were tested with conditions from the easterly direction found to result in largest waves conditions at Buffalo Beach.

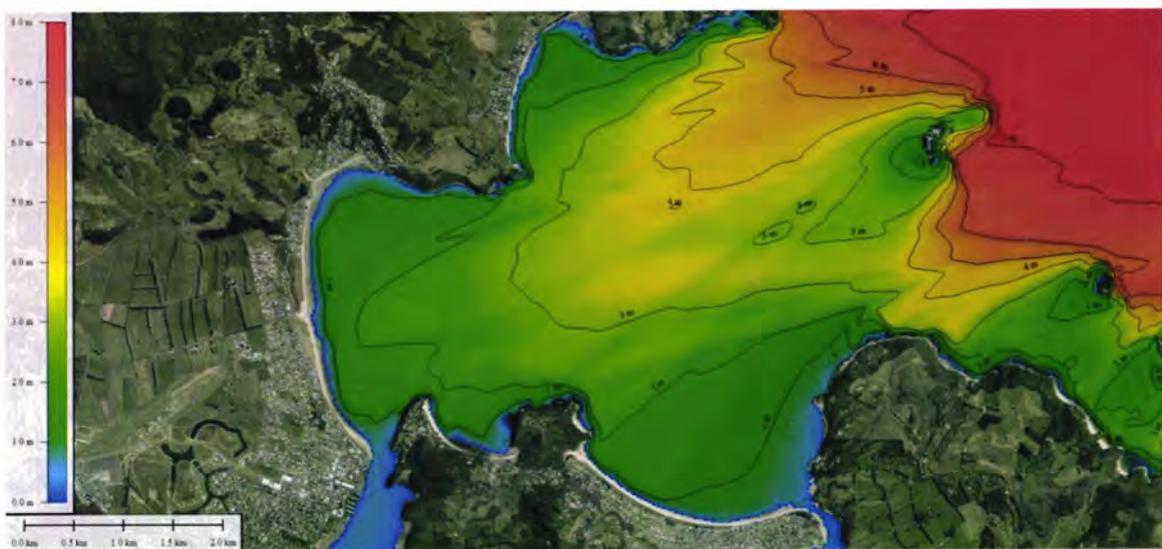
The SWAN model predicts a nearshore wave height of 2.15 m at the 5 m depth contour offshore of Buffalo Beach for a 1% AEP easterly event. Wave set up has been assessed based on the methods described within the Coastal Engineering Manual (CEM, 2006), with the resulting estimated wave set-up being 0.6m.

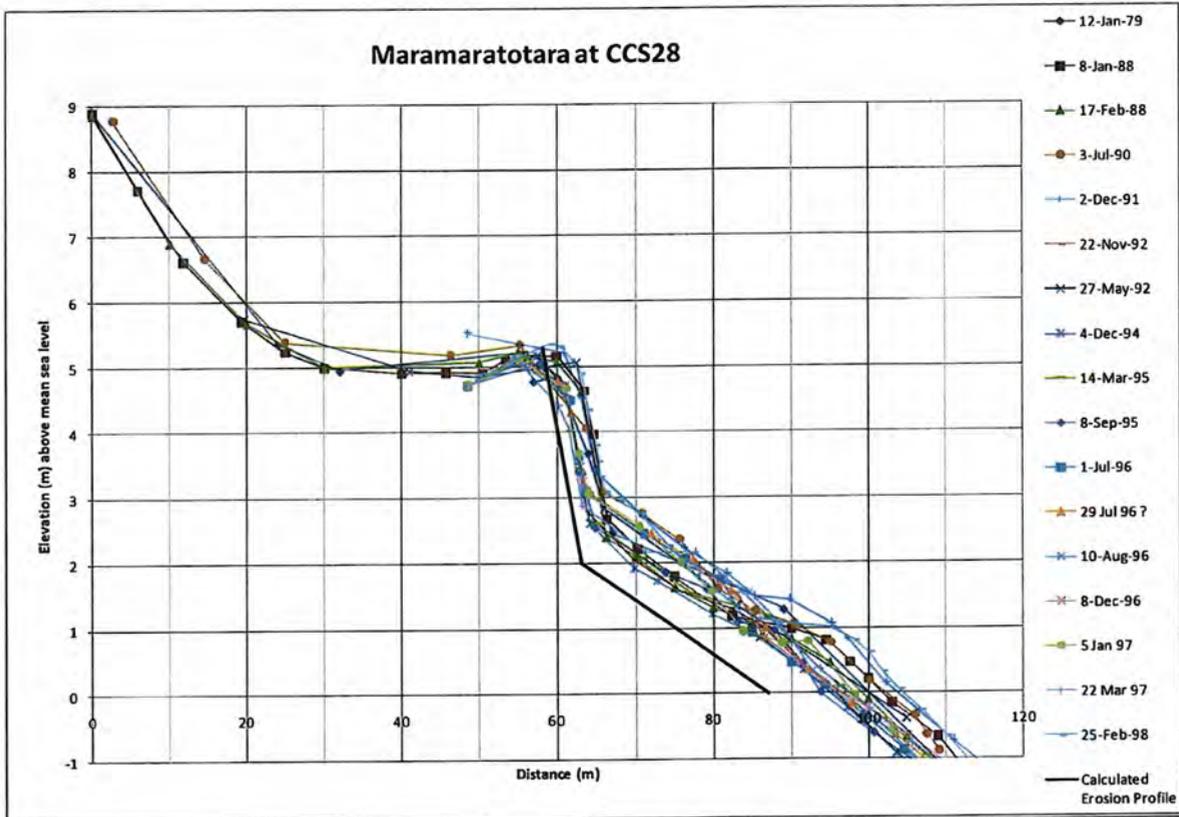
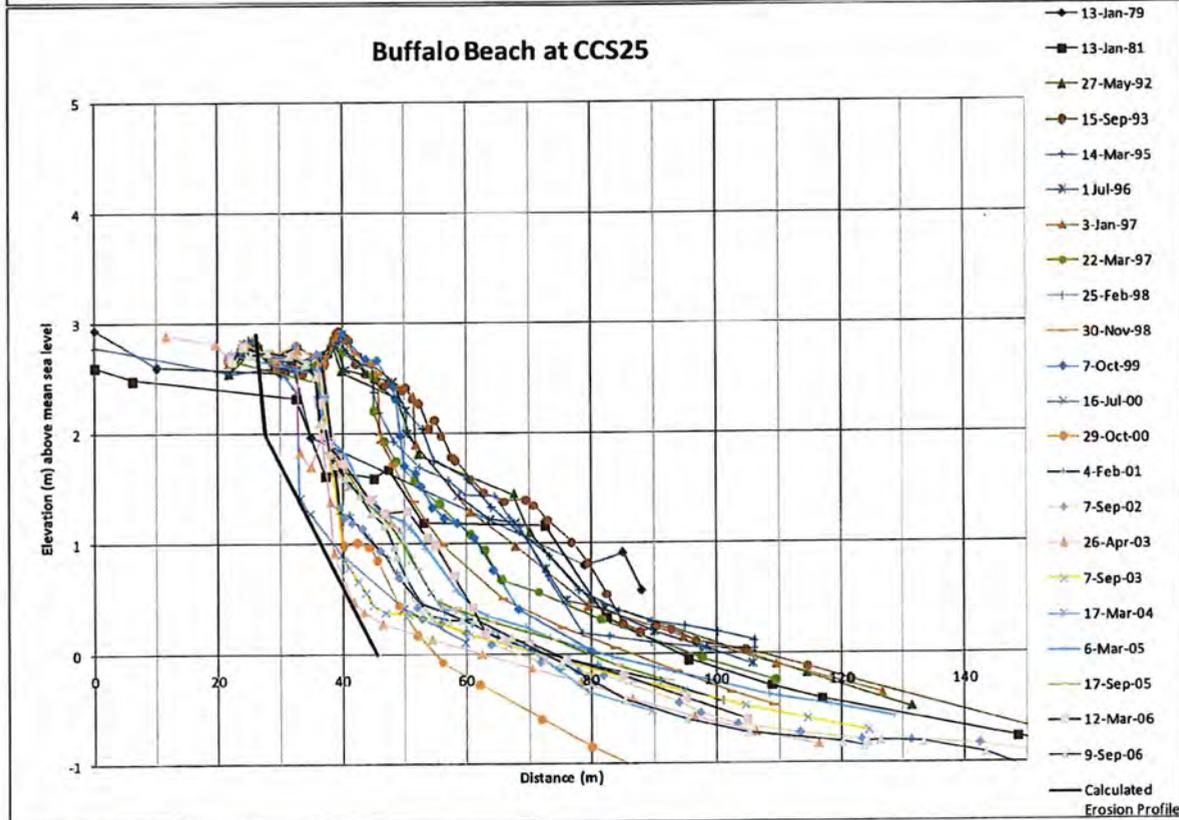
Beach cross-section profiles have been surveyed and monitored at Buffalo Beach since 1979, and monitoring cross-section CCS25 (see below), is located to the north of the site, in Macrocarpa Reserve. This monitoring location is considered close enough to be typical of beach fluctuations at the site, and the results of the monitoring were presented in the Focus Resource Management Group report "Coromandel Beaches-Coastal Hazards: Review of Primary Development Setback at Selected Beaches" (2009).

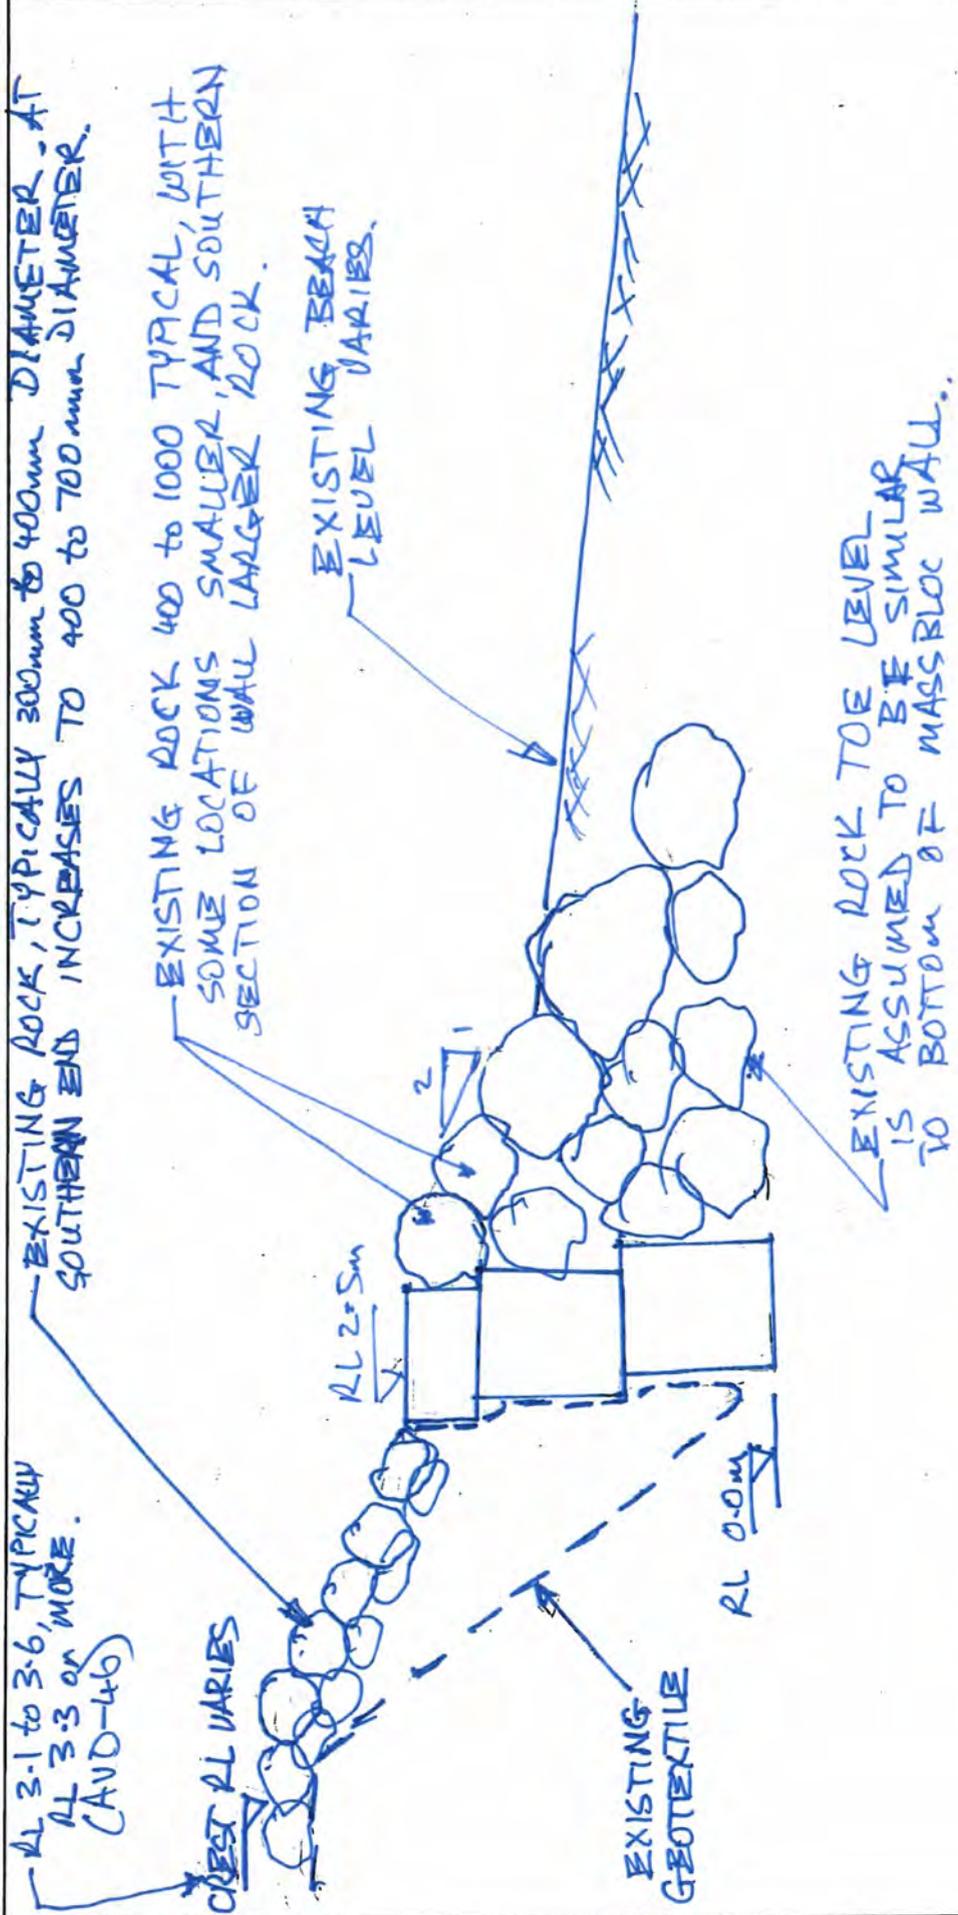
TYPICAL EXISTING WALL CONSTRUCTION

- A small rock toe appears to have been constructed in front of the lower Massblocc layer, at the time of construction. This has subsequently been enhanced with additional rock, which for the majority, but not all properties, this rock now has a crest level with the top of the Massbloccs. This now provides a rock armour face to the Massbloccs. We understand, the additional rock has been placed following occasions when the rock toe was close to being undermined and settled. At the time of our inspections, only the top metre or so was exposed, and the remainder of the toe rock was covered by sand. We do not know the elevation of the base of the toe.

- The rock size in the toe armour varies along the wall, with sizes in the central and northern area typically 400mm to 1000mm diameter rock, while the rock in the southern section was larger and typically ranged between 500mm and 1200mm diameter. The slope of the face of the toe rock was measured at three locations and is estimated to be approximately 1V:2H.

- Above the Massblocc level, the top of the seawall consists of an armoured berm to an elevation varying between RL3.1m and 3.6m AVD-46, with most surveyed levels at RL3.3m or above. The rock size in the central and northern sections of the crest section of the seawall appear to be approximately 300mm to 400mm diameter, whereas in the southern section of the seawall the size increased to be typically 400mm to 700mm diameter rock. We were informed that, on many properties, this upper rock protection extends well back into the crest berm fronting the properties.

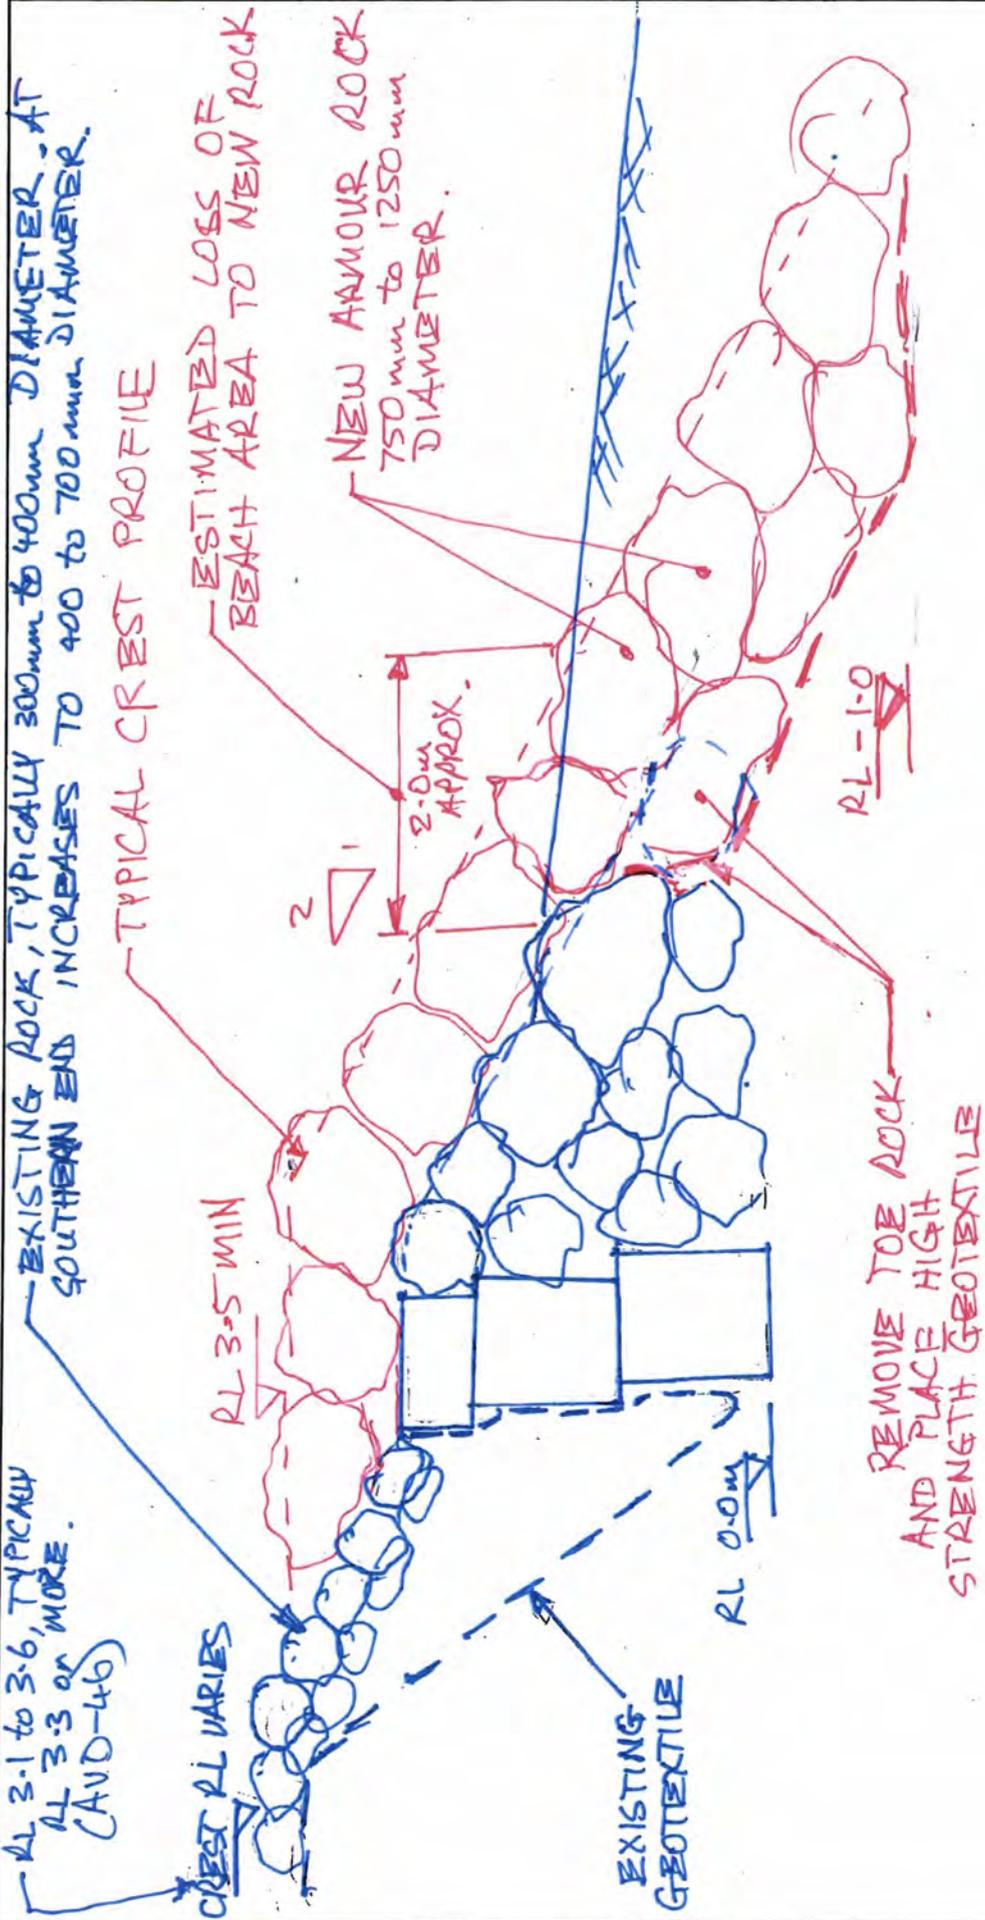
PROPOSED SEAWALL UPGRADE WORKS
OPTION A: EXISTING WALL REMAINS.

Typical sketch cross-sections of the option to strengthen the existing seawall are included in Appendix E. The proposed seawall upgrade works involve placing additional larger armour rock over the outer face of the existing seawall. This larger armour provides protection against larger waves anticipated to occur during extreme storm events and allowing for future sea level rise, and also has the benefit of reducing wave overtopping during extreme storm events.

Two options have been presented, with the difference between the two options being that Option A simply encases the existing seawall in larger rock, whereas Option B includes installing additional geotextile layers beneath the existing rock armour to provide greater protection against sand being eroded through the existing rock armour, during extreme storms when the beach levels are low.

We understand that the existing toe armour has settled during storms in the past. The placement of a geotextile beneath the existing rock, will assist in reducing any future settlement, however we do not have any information on the level of the underside of the existing toe rock, so do not know if any future settlement risk still exists. If Option A is selected by the Homeowners, there may be a need to top-up the Armour rock crest level in the future with additional rock, if settlement occurs. This could be done as a maintenance activity in the future if and when required.

The general elevation of the rock crest has been set at RL 3.5m, which allows for crest rock of typical 1.0m diameter to be placed on top of the Massblocc wall units. As discussed above, typical existing rock berm elevations at individual properties vary between 3.1m and 3.6m RL, with most property

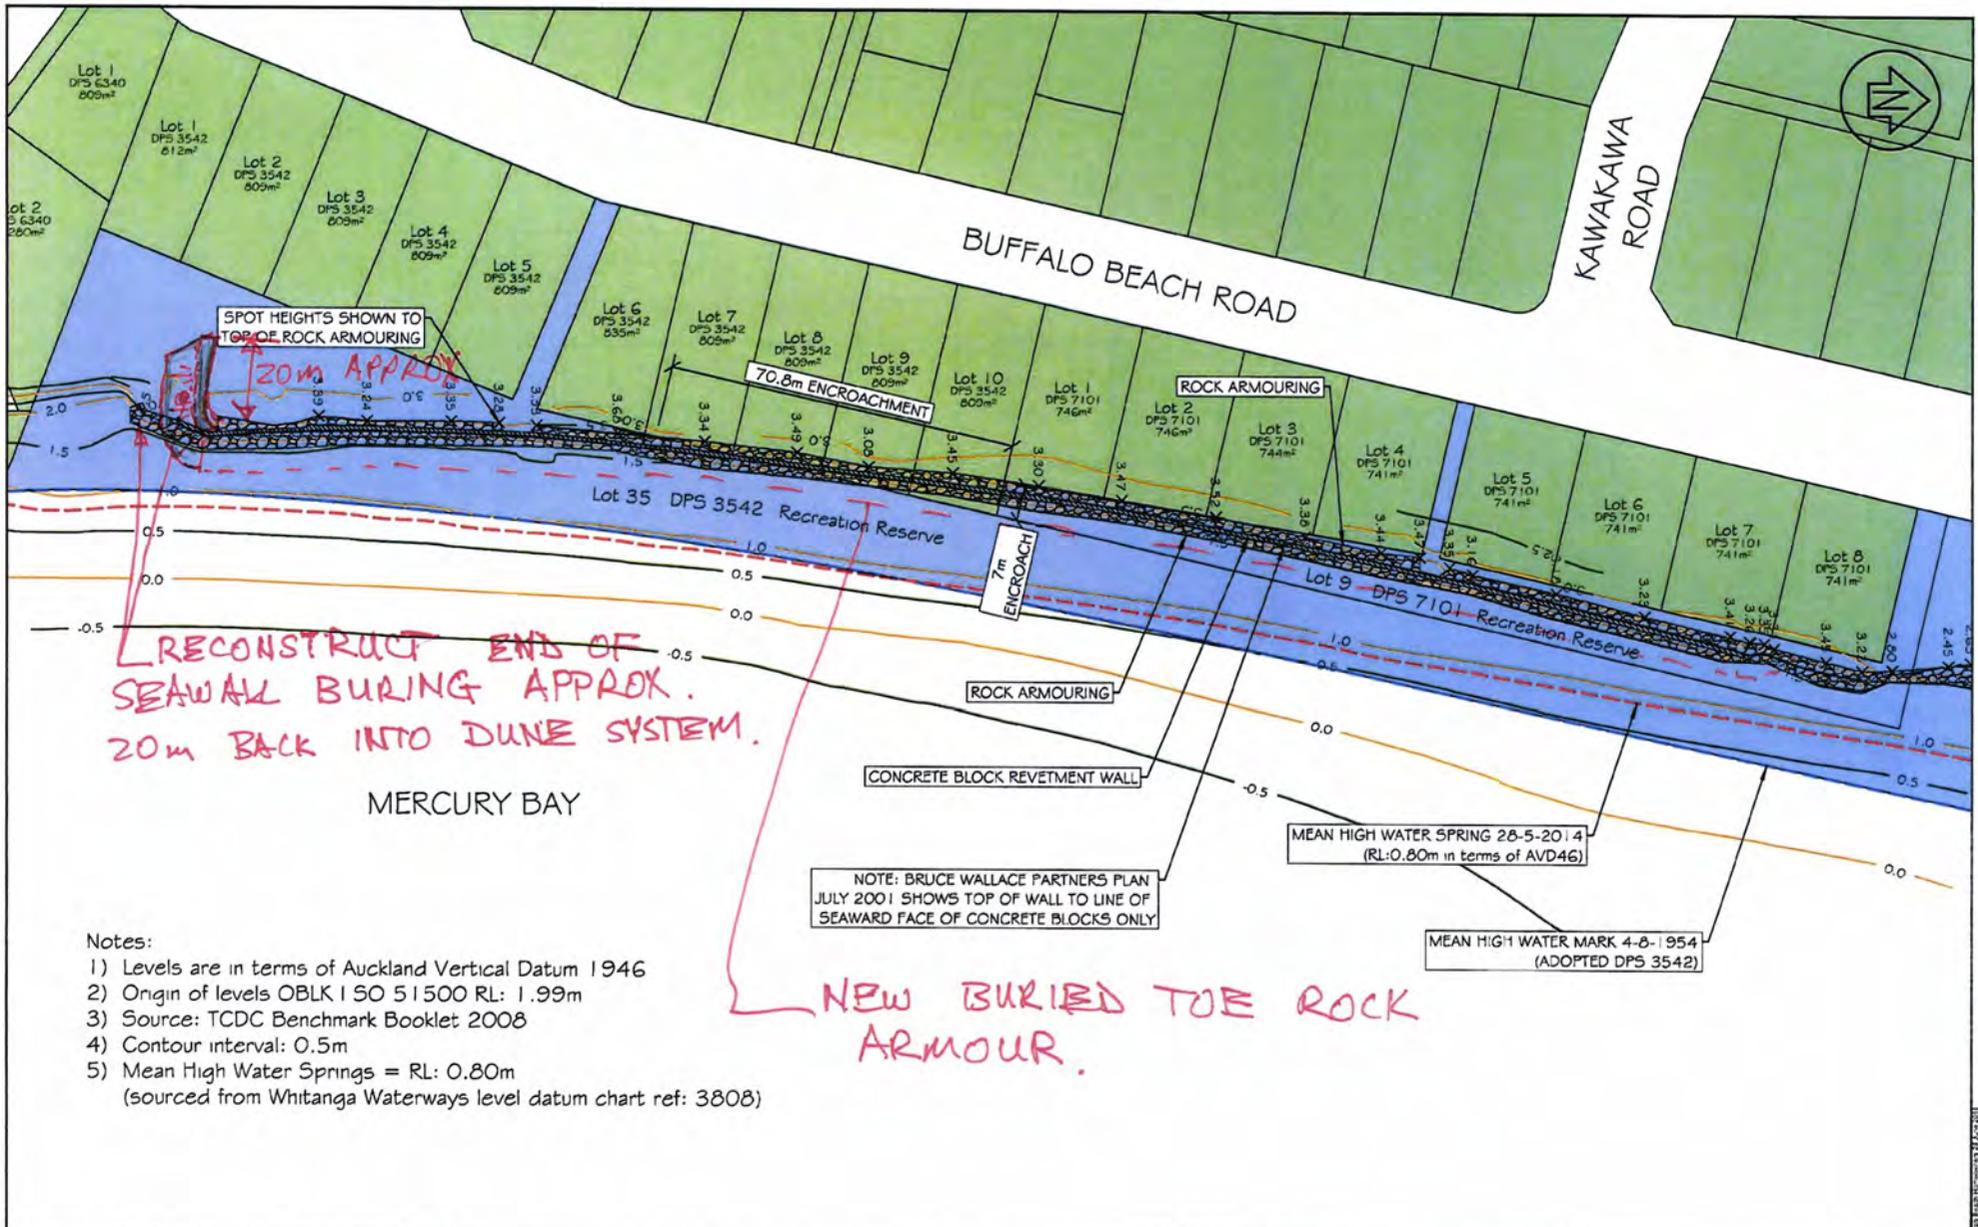
SKETCH SK 04.

RECONSTRUCT END OF SEAWALL BURING APPROX. 20m BACK INTO DUNE SYSTEM.

NEW BURIED TOE ROCK ARMOUR.

In order to improve the long term stability of the end of the seawall, we suggest the southern 18m section is removed and reconstructed curving back toward the dune, and is buried well into the beach backshore dune area as shown on Sketch SK04 (refer Appendix E). We also recommend Council continue with beach dune management in this area in an attempt to reduce the risk of the new end of the seawall being outflanked in the future.
