# **Regional flood summary: Rainfall event 7 to 12 March 2017**

Prepared by: Heather Craig

For:  
Waikato Regional Council  
Private Bag 3038  
Waikato Mail Centre  
HAMILTON 3240

March 2017

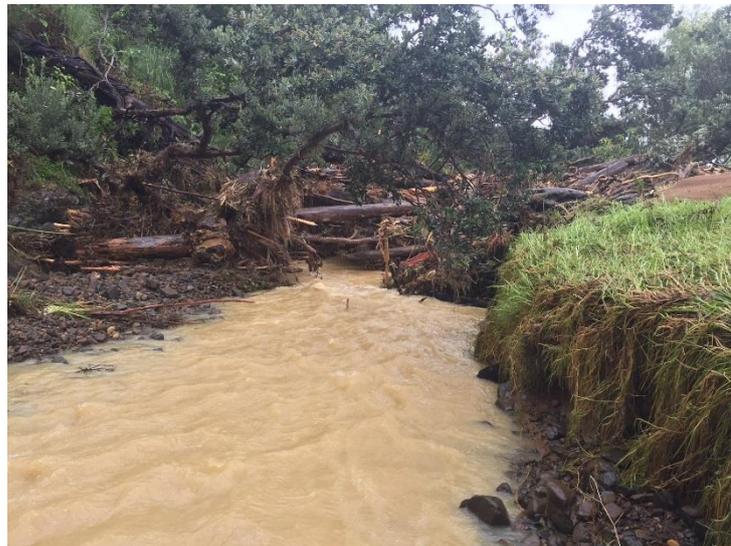
Flood protection schemes at Te Puru, Waiomu and Tapu were visited by WRC staff on the 8 March. The schemes were observed to be performing well with flow contained within the banks and stream mouths open. Some erosion was observed at Pohue and Manaia, and a blockage, likely formed during the initial rainfall event, was removed from the Wairotoroto Stream on the morning 10 March (Figure 11).

**Figure 11: Debris blockage in Wairotoroto Stream.**

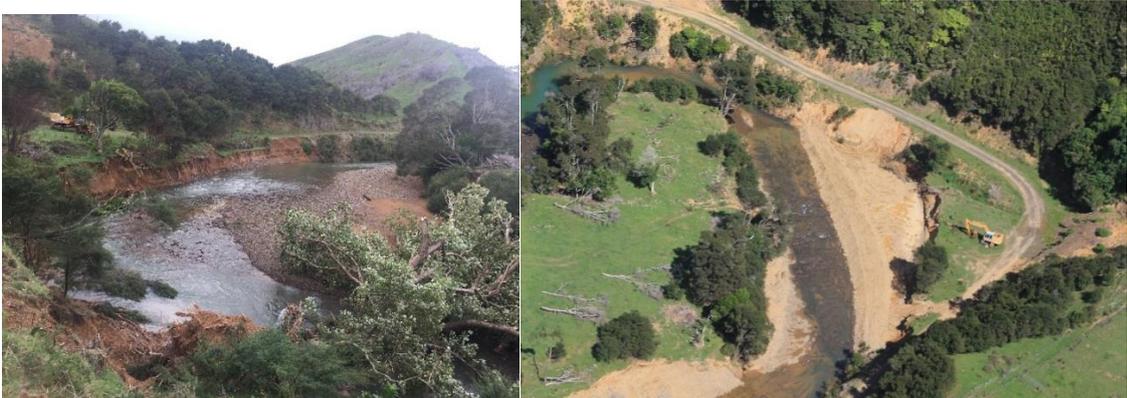
The most significant damage was to the catchments south of Coromandel Town to Waikawau. In the Waikawau and Manaia rivers, there was significant stream bank erosion and landslips (Figure 12). This damage will make up the majority of the remediation work and recovery costs. The Thames Coast Schemes were relatively unaffected even though there was significant rainfall and flooding in many areas.

**Figure 12: Damage on the Waikawau River, and (right) temporary bund in place to prevent erosion of hillside at the same location**

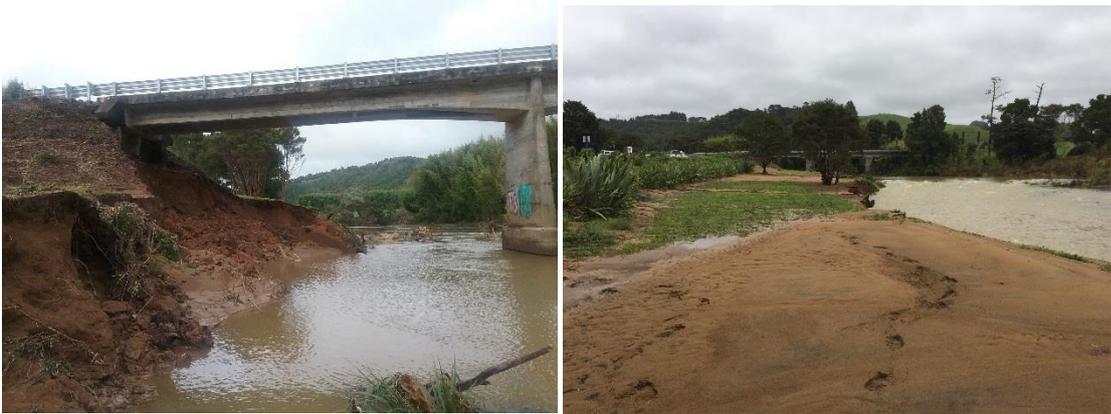
The Waiwawa River burst its banks in the early hours of the morning of 8 March, which inundated the Coroglen Saleyards and the southern approach to the bridge over the river. Significant erosion occurred on the underside of the bridge on the true right bank side running from near the domain toilets to the stockyards. Significant sediment deposits occurred throughout the domain in Coroglen, including roading debris that were dislodged by flood waters. This was inspected by WRC operations staff and Beca Engineering on behalf of NZTA (Figure 13). Beca also spray painted the banks to track any further erosion.

**Figure 13: Photographs taken on Thursday 9 March showing erosion under the State Highway 25 Bridge over the Waiwawa River (left), with silt deposits showing the extent of inundation (right).**

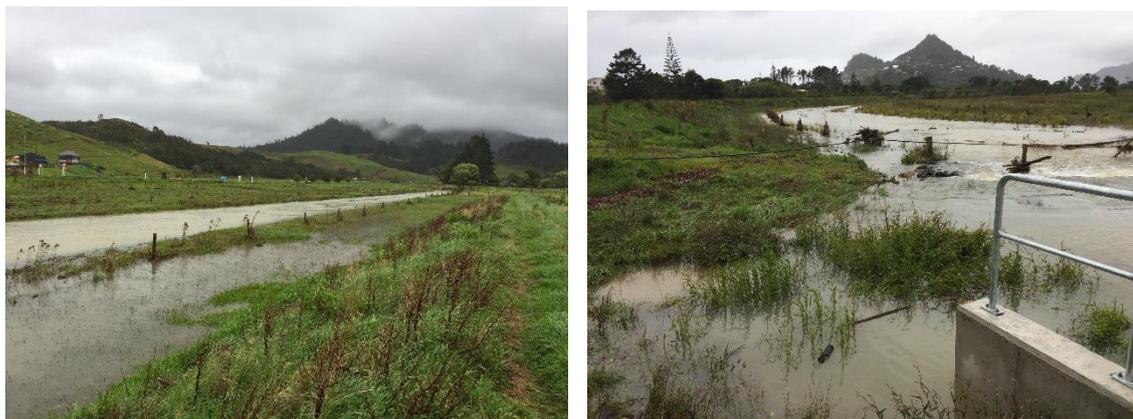
**Figure 14: Photographs taken on Thursday 9 March showing Grahams Creek Flood Protection Scheme functioning in high flows.**

The relatively recently operational Grahams Creek Flood Protection Scheme performed well throughout the event (Figure 14), with small scale ponding nearby the only issue reported in the vicinity.

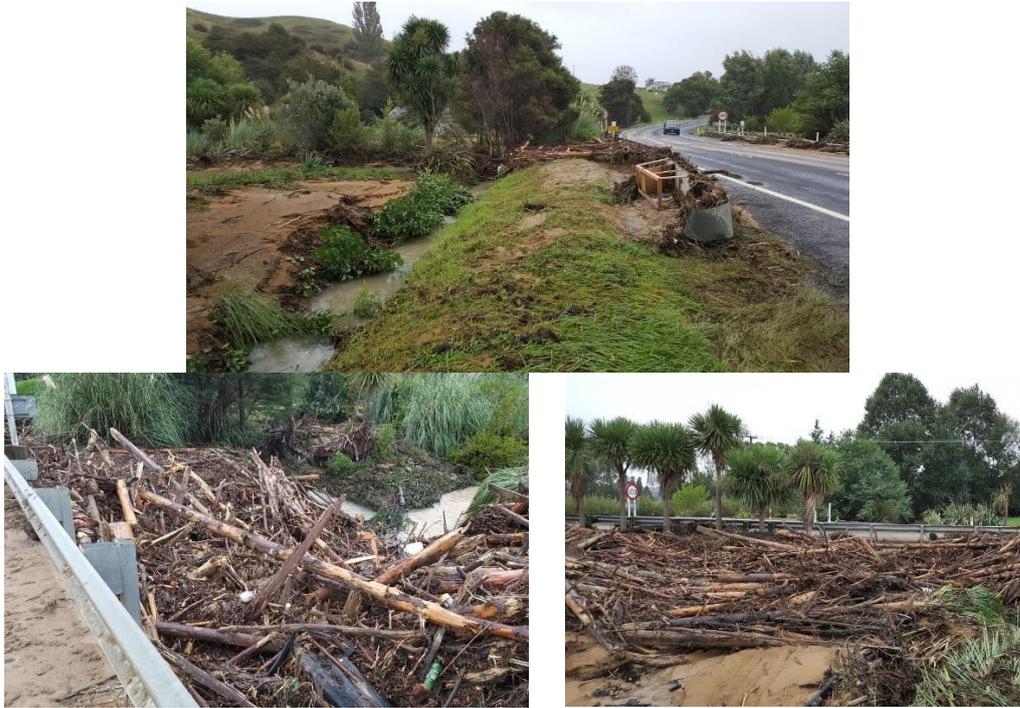
On 10 March a contractor observed a large amount of forestry debris upstream in the Te Weiti floodplain, which was at risk of travelling further downstream and re-blocking the area around State Highway 25. Rayonier (forestry company) were contacted and advised that this could not be cleared until 13 March. The WRC Resource Use team were also advised of the issue.

**Figure 15: Photographs taken on 9 March showing floodwaters and debris at Te Weiti Stream.**

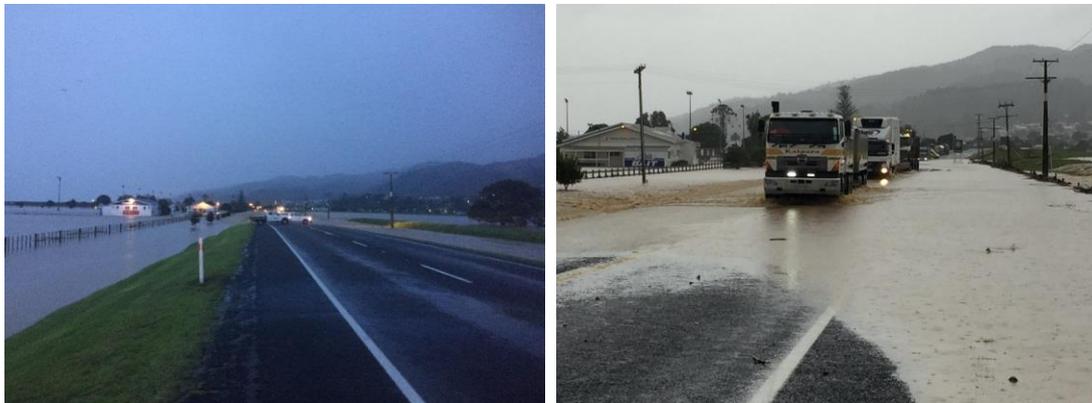
**Figure 16: Photographs taken on 8 March (approx. 0645 and 1000 hours) showing the Kauaeranga State Highway 25 Spillway operating.**

Landowners were advised of impending spillway operation at approximately 04:00 on 8 March and some stock were moved. Illegal campers were evacuated by WRC staff from Rhodes Park in the early hours of the morning of 8 March as it became clear that spillway operation was inevitable.

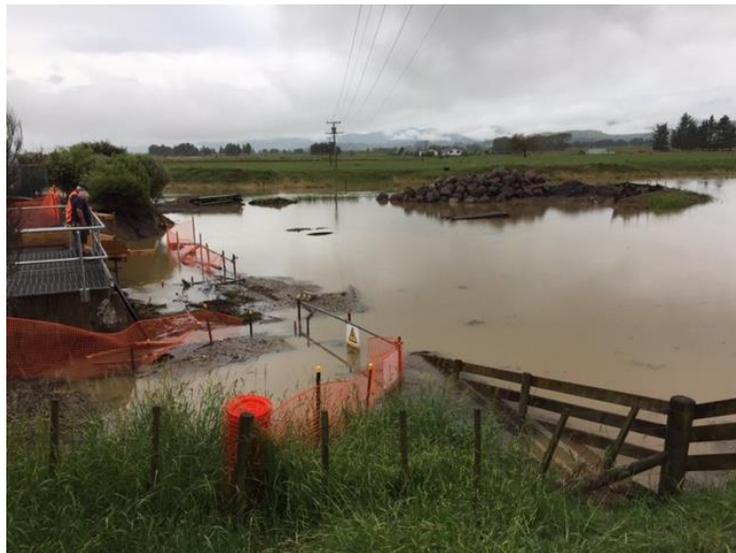
Stocks pumpstation (Waihou Scheme) was undergoing an upgrade at the time, meaning that it was not operating and a coffer dam was in place. The coffer dam was overtopped by the increased flows (Figure 17), and the site was handed over from the contractor back to WRC to manage. This resulted in the inundation of WRC-owned land immediately proximal to the pumpstation. A pump was set up with probes to maintain the water level.

**Figure 17: Stocks Floodgate on 8 March showing coffer dam overtopping.**

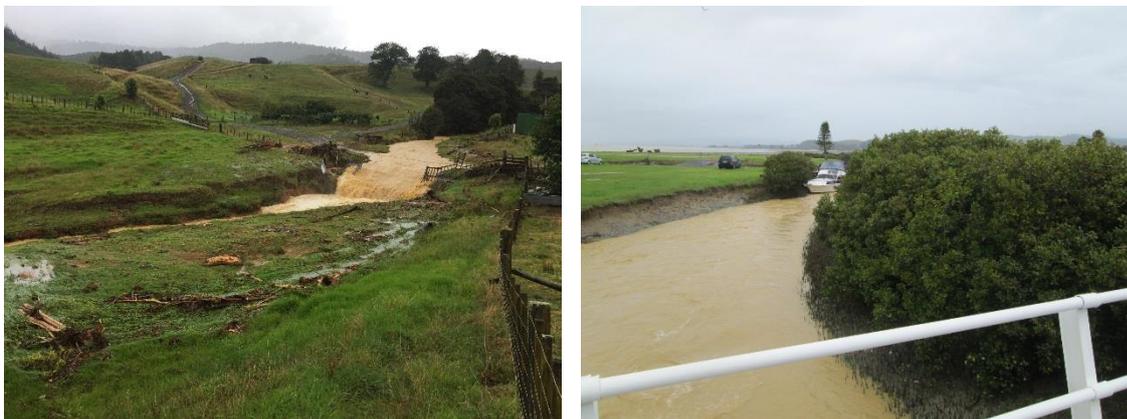
WRC staff were sent to investigate the situation in Kaiua (Figure 18), where several houses were inundated and farmland damaged. Hauraki District Council assisted residents with sandbagging to protect properties from flood water. Some of the flooding originated from the Haurahi Stream where the channel capacity was reduced because of mangrove growth. WRC does not currently have any channel clearance agreements in place here.

**Figure 18: Floodwaters and farmland damage; and mangroves encroaching Haurahi Stream (right) on 8 March (when WRC staff visited) at Kaiaua (left).**

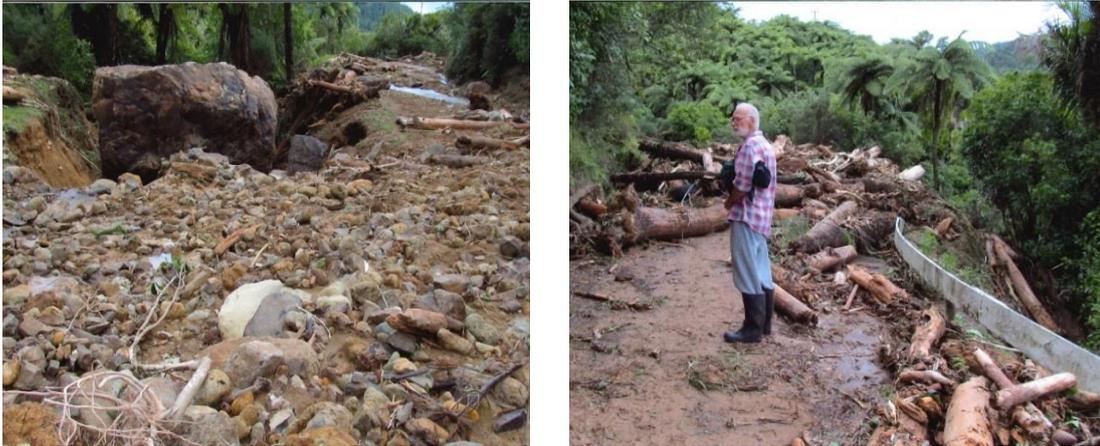
WRC operations staff also attended affected areas in Puriri. Pasture and numerous private fences were damaged by large amounts of forestry and flood debris (Figure 19). WRC staff assessed and were able to respond to questions from the public.

Figure 19: Flood debris at Upper Puriri River on 11 March.
