Waikato region shallow lakes management plan: Volume 2

**Shallow lakes resource statement:
Current status and future
management recommendations**

Prepared by Tracie Dean-Speirs & Keri Neilson (Waikato Regional Council) with input from Paula Reeves (Wildland Consultants) and Johlene Kelly (Alchemists Ltd.)

10 October 2014

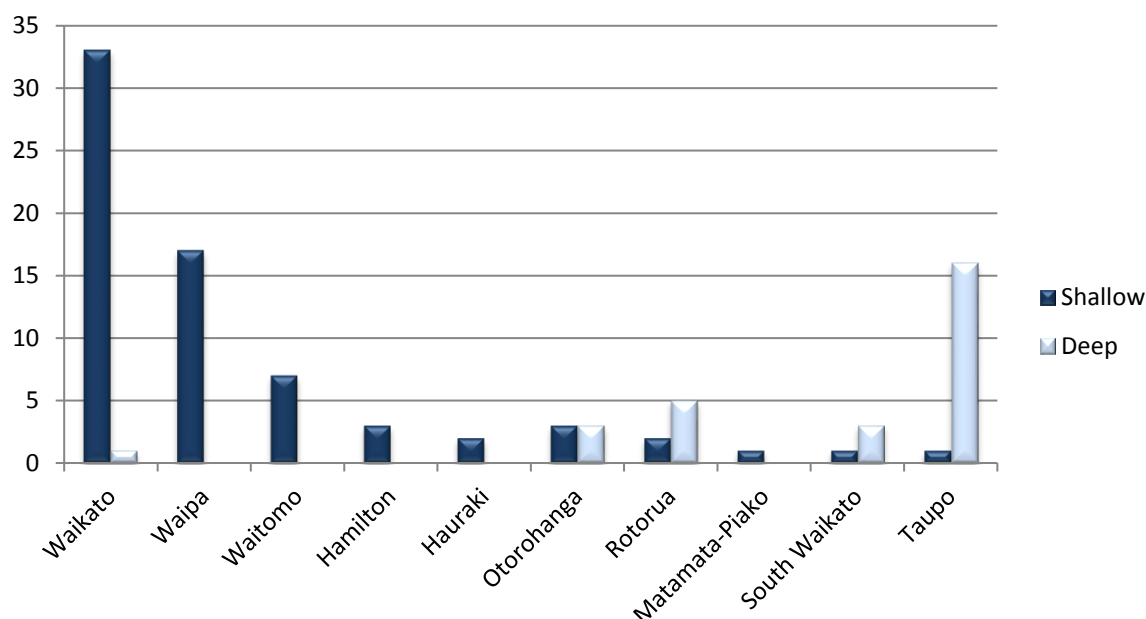
Figure 2 The number of shallow and deep lakes within districts in the Waikato region

Shallow lakes are found throughout the region, having formed in conjunction with the Waikato River system, the region's coast and cave systems, and the formerly extensive peat bogs of the region (Figure 1). Shallow lake 'hotspots' occur in the Waikato (peat, riverine, dune and karst lake types), Waipa (mostly peat lakes) and Waitomo Districts (mostly dune lakes) as shown in Figure 2.

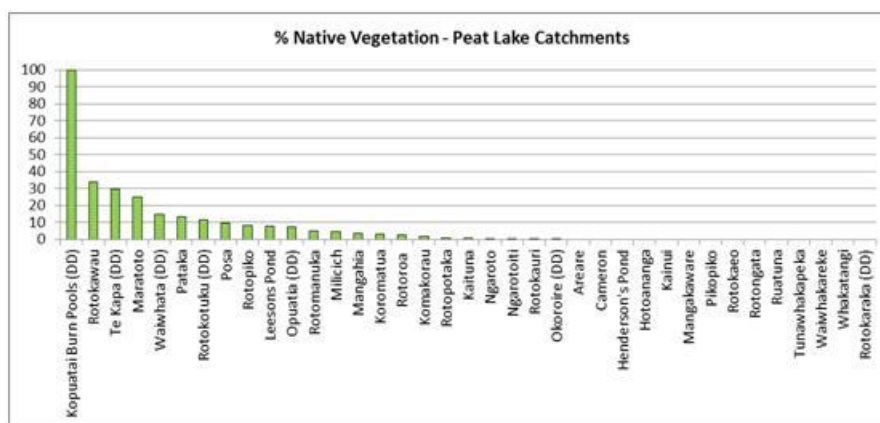
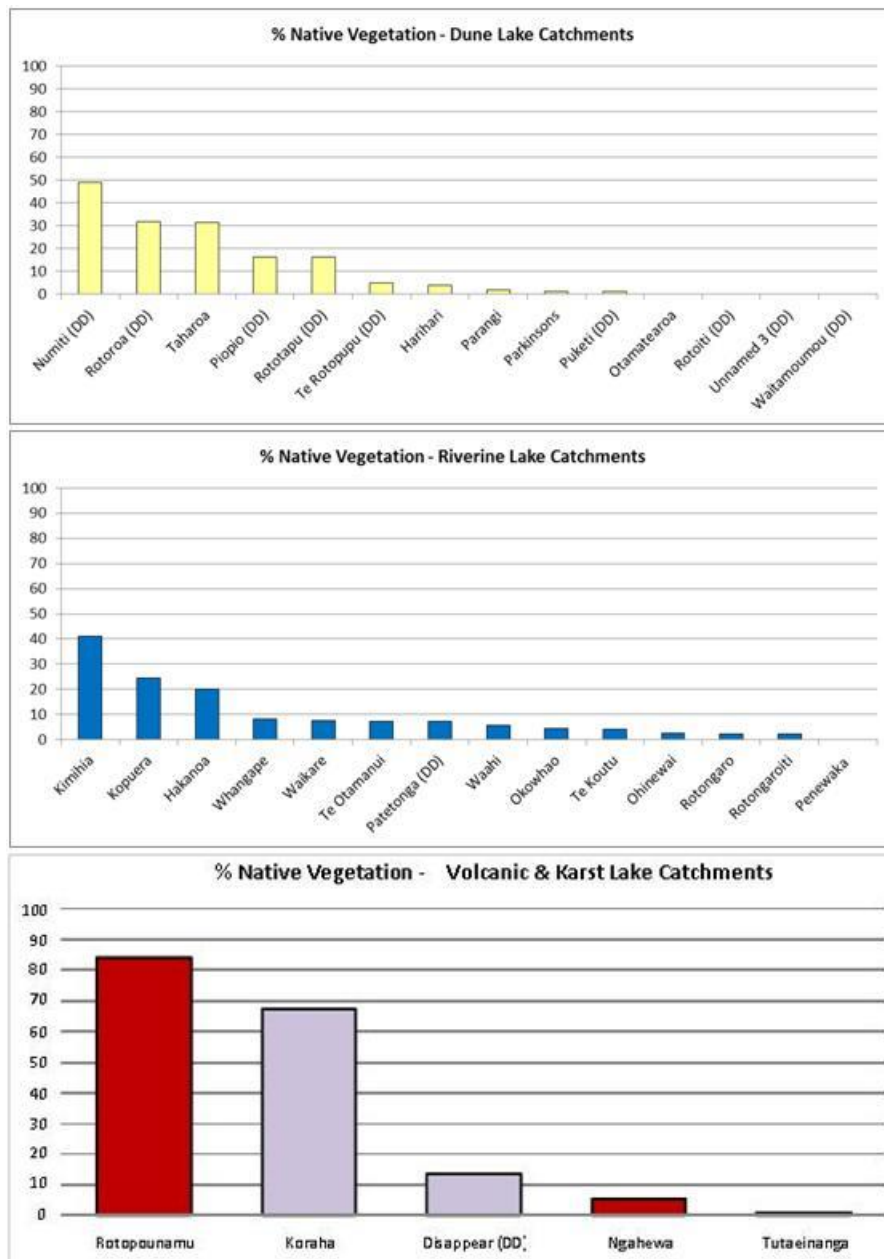
Figure 3 Estimated native vegetation cover in the catchments of shallow lakes (by type) in the Waikato region

Lake types are indicated by colour in the following way: **volcanic**, **karst**.

The only shallow lakes that still have largely forested catchments are Lake Rotopounamu which is situated within a conservation area, and the Kopuatai Burn Pools that are associated with the Kopuatai peat dome (Figure 3). Lake Koraha also has greater than 50% of its catchment in native forest, and is located within a conservation area. The Taharoa dune lakes (Lakes Numiti, Rotoroa, and Taharoa) have retained at least 30% native vegetation within their catchments, and WRC has made initial approaches to the Taharoa Lakes Trustees to assess the condition of the lakes and identify future management options to safeguard them.

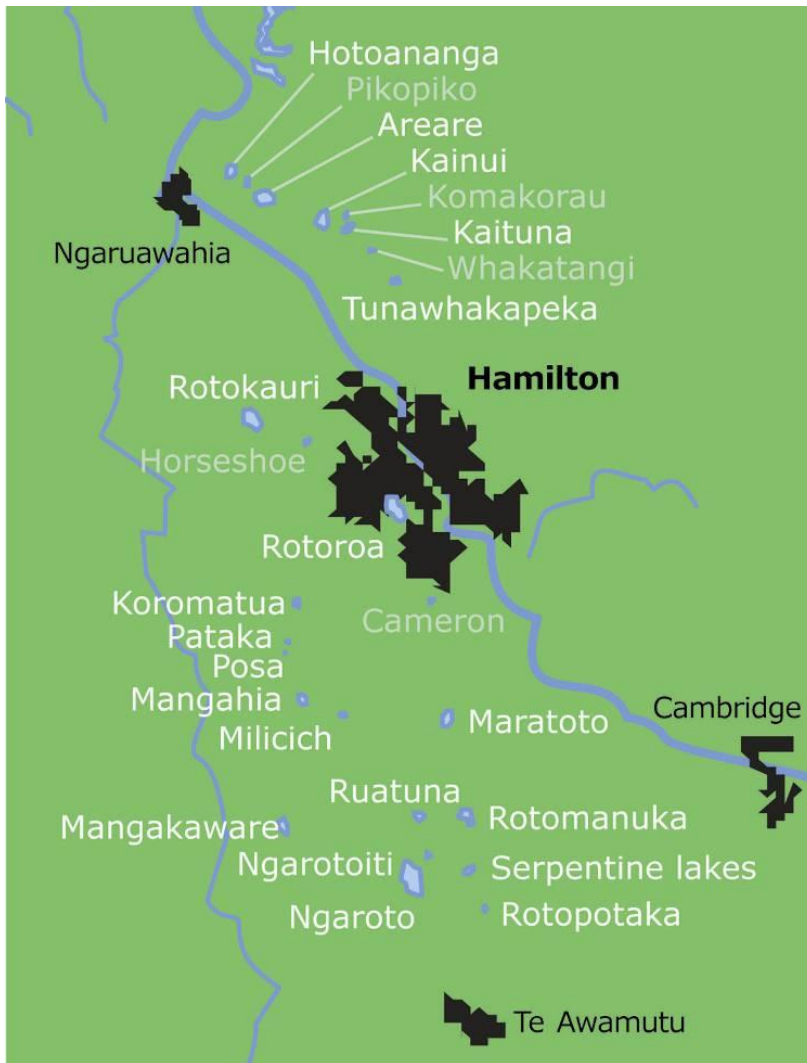
Figure 4 Peat lakes in the Waikato region

The Waikato peat lakes are concentrated in the Waikato and Waipa Districts and represent the largest collection of this wetland type in New Zealand. The lakes formed in the historic floodplain of the Waikato River, where sand and gravel from the Waikato River blocked valleys at the time when the river changed course.

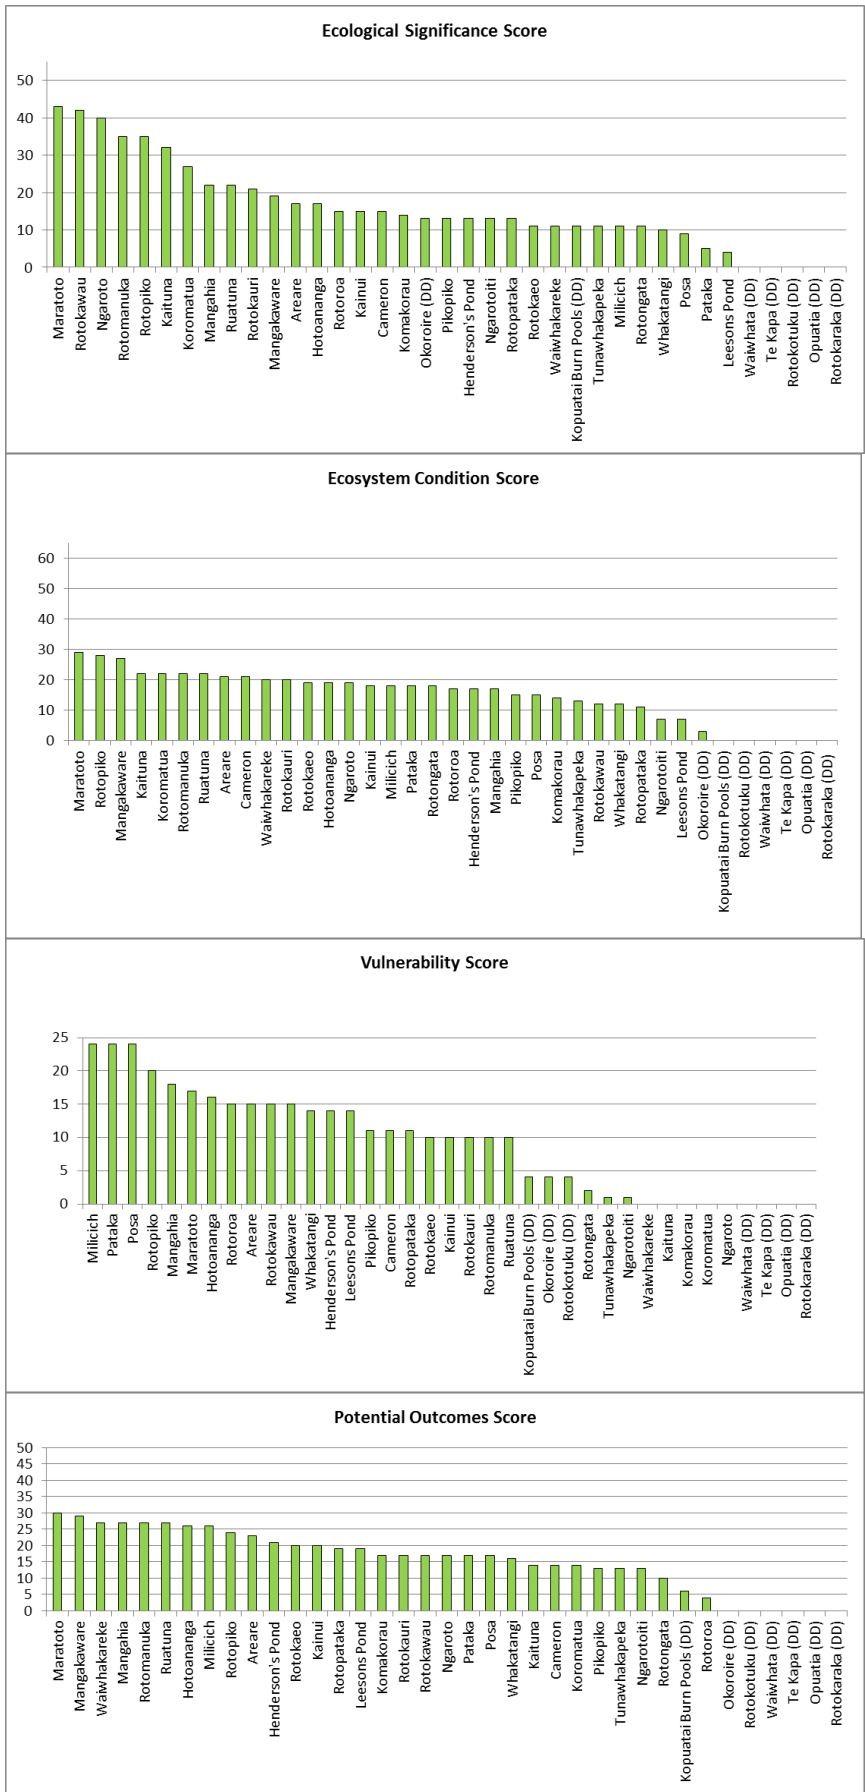
Figure 5 Peat lake scores (including best estimates) for different aspects of the lake prioritisation method used to rank lakes in the Waikato region

The majority of peat lakes have similar ecosystem condition scores (of 15-20) that reflect their poor water quality, the presence of pest fish, the small size of their wetland margins and the extent of hydrological modification that has arisen from changes to catchment land use (ie drainage).

The most vulnerable peat lakes (Milicich, Pataka and Posa) are small lakes where land intensification has occurred or is likely to occur as a result of further drainage. These lakes are not thought to contain the pest fish, koi carp.

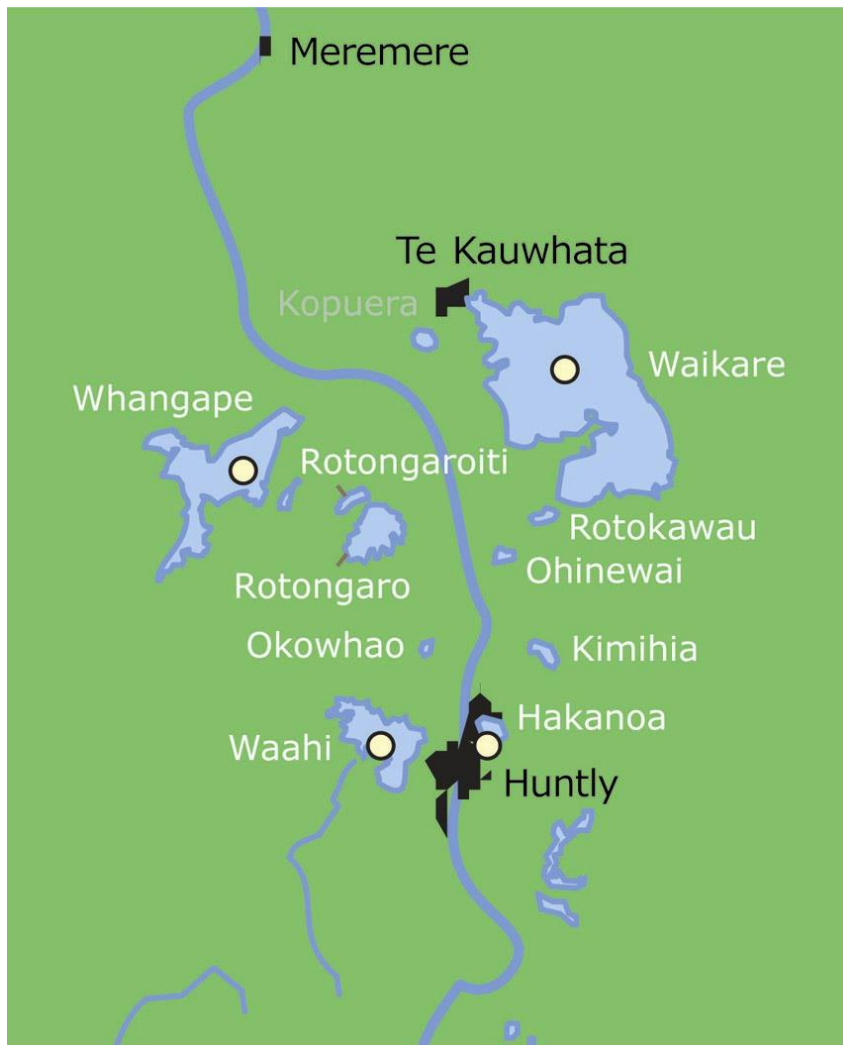
Figure 6 Location of riverine lakes associated with the Waikato River (source – Environment Waikato).

There are 14 riverine lakes in the Waikato region that are associated with the Waikato (12 lakes), Waipa (Te Otamanui Lagoon) and Piako Rivers (Patetonga Lagoon). The lakes within the catchment of the lower Waikato River are part of an extensive river floodplain wetland system that includes Lakes Whangape, Waahi, Waikare and the internationally important Whangamarino wetland. Together, these environments create a nationally significant, interconnected system of open water, wetlands and swamp environments that provide important habitat for native plants and animals.

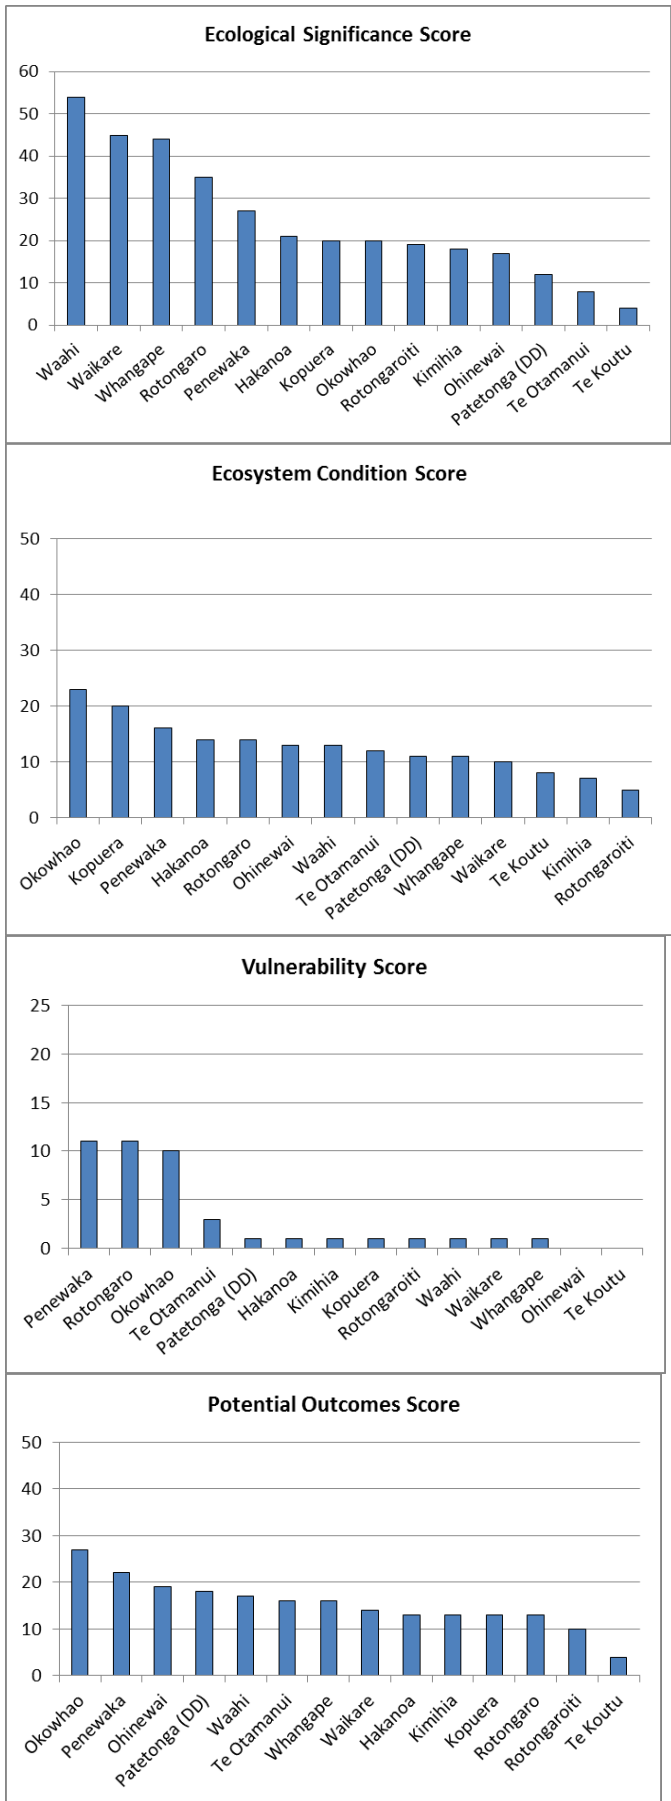
Figure 7 Riverine lake scores for different aspects of the lake prioritisation method used to score and rank the biodiversity values of lakes in the Waikato region (Wildland Consultants 2011a).

Ecosystem condition scores are low to moderate for all riverine lakes. All riverine lakes have poor water quality and most experience regular algal blooms. The interconnectedness of the riverine lakes facilitates the spread of pest fish and weeds so that almost all riverine lakes support pest fish and wetland weeds. Their poor condition translates to low vulnerability scores since many of the threats to these lakes have already occurred and are well entrenched.

Potential outcome scores are mostly low, as they recognise the practical difficulties and uncertainties associated with shallow lake restoration – particularly for the large riverine lakes that have highly modified hydrological regimes and extremely large catchment sizes.

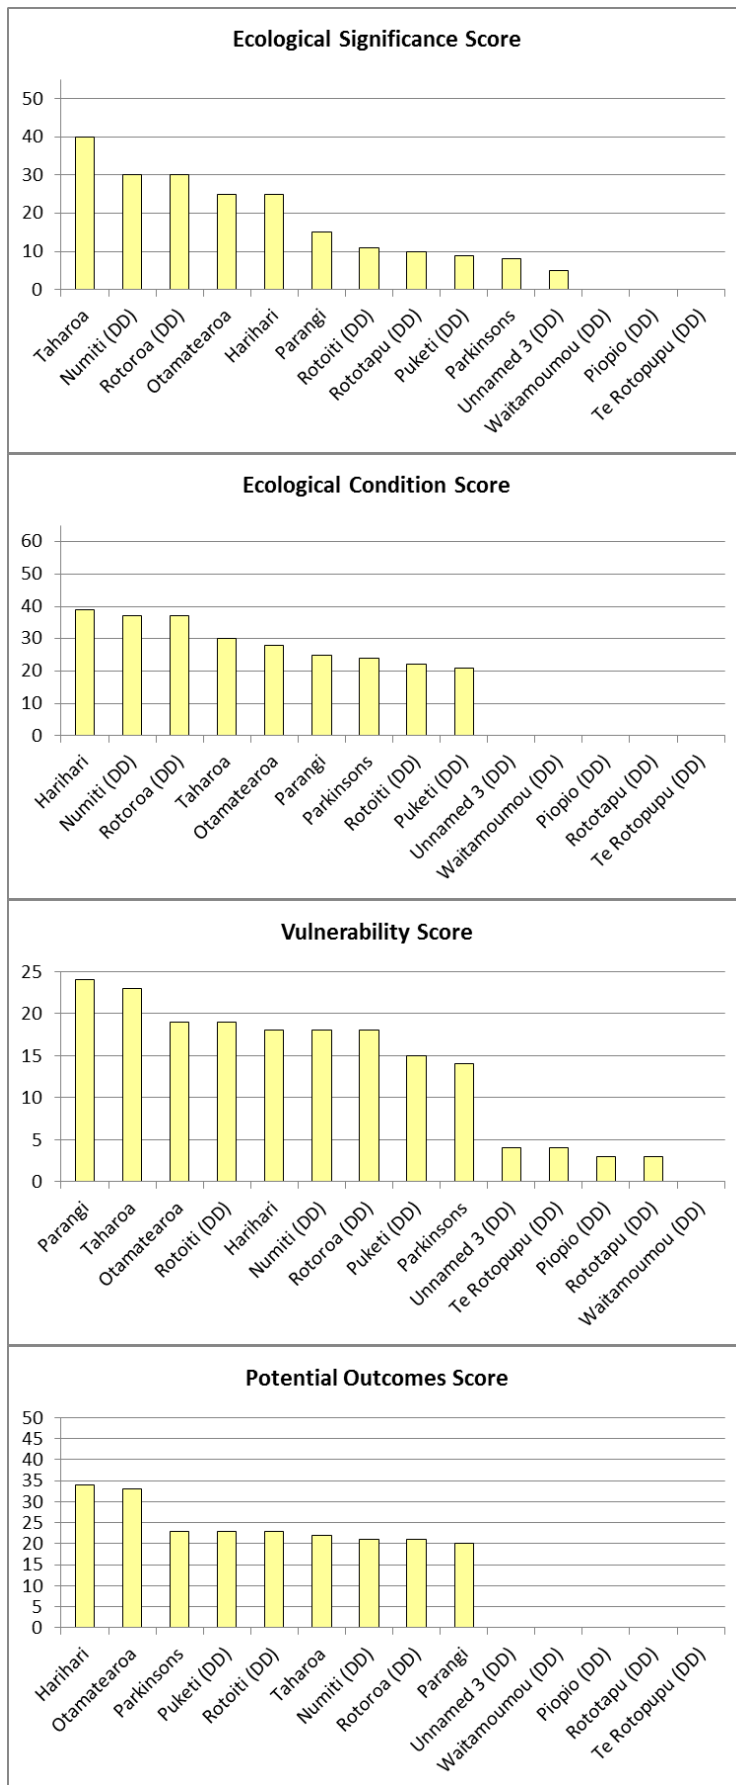
Figure 8 Dune lake scores (including best estimates) for different aspects of the lake prioritisation method used to rank lakes in the Waikato region (Wildland Consultants 2011a)

The Taharoa lakes, Lake Harihari and Lake Otamatearoa have the highest ecological significance and condition scores but also score highly for vulnerability.

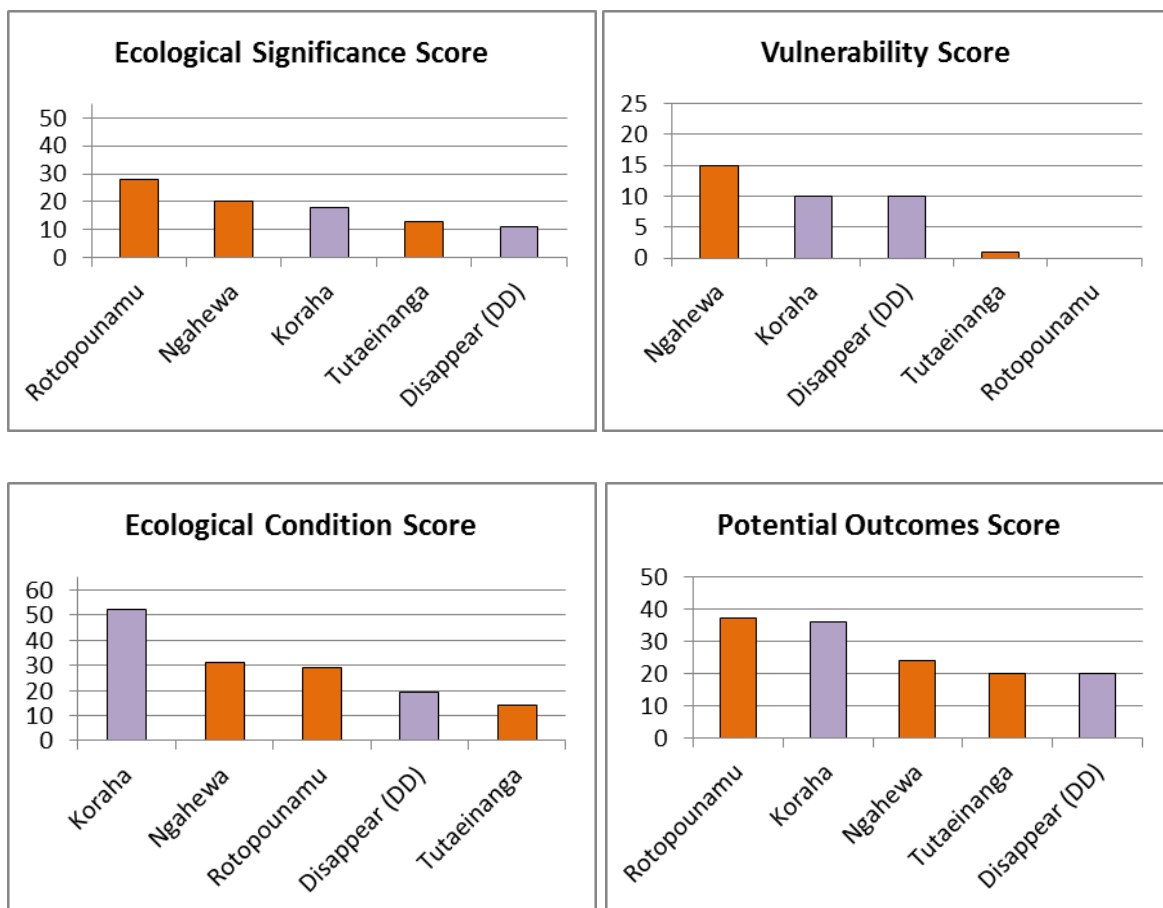
Figure 9 Volcanic and Karst lake scores for different aspects of the lake prioritisation method used to rank lakes in the Waikato region for their biodiversity values (Wildland Consultants 2011a).

Unfortunately, little is known about these lakes, and further information is required to assess their biodiversity values and overall condition. The following figures show their preliminary scores for different aspects of the lake prioritisation method that was used to rank karst and volcanic lakes in the Waikato region for their biodiversity values. Lake types are indicated by colour in the following way: volcanic, karst.
