Aotea catchment management plan supporting information

Catchment Management Plan

Supporting information

Aotea Catchment Management Plan: Supporting Information

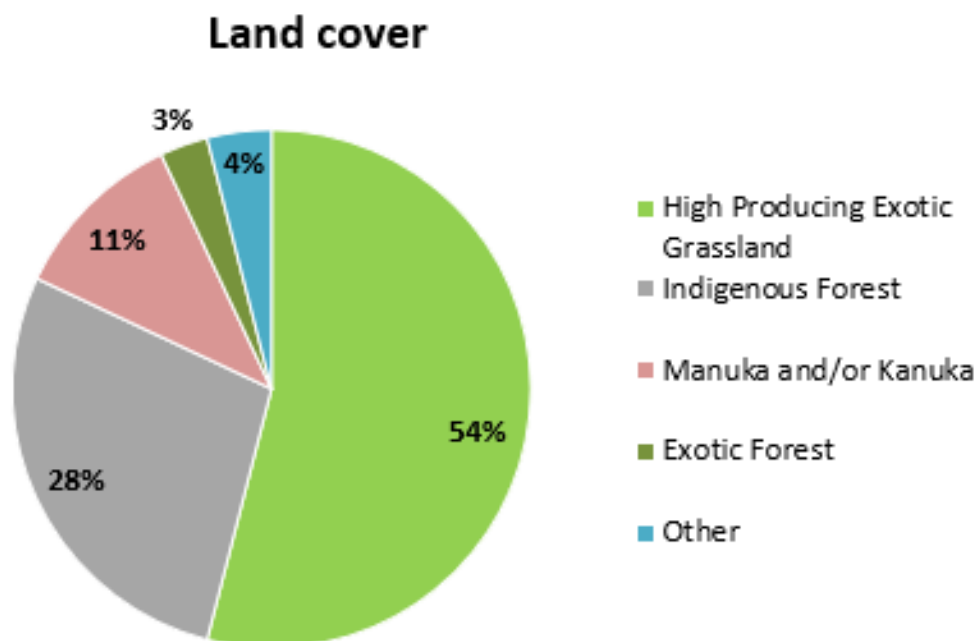
Figure 5. Percentage of land cover within the Aotea catchment (Singleton, 2018).

The current land cover within the Aotea Harbour catchment is shown in Figure 4 and is summarised in Figure 5 (Singleton, 2018). Just over half of the Aotea catchment is in pasture (54 %). More than a third (39 %) is in native woody cover that is located in the eastern hills of Pirongia Forest Park. Forestry accounts for approximately 3 % of the catchment, whilst there is uncertainty about the remaining 4 % (unspecified). There is very minimal built-up area within the catchment.

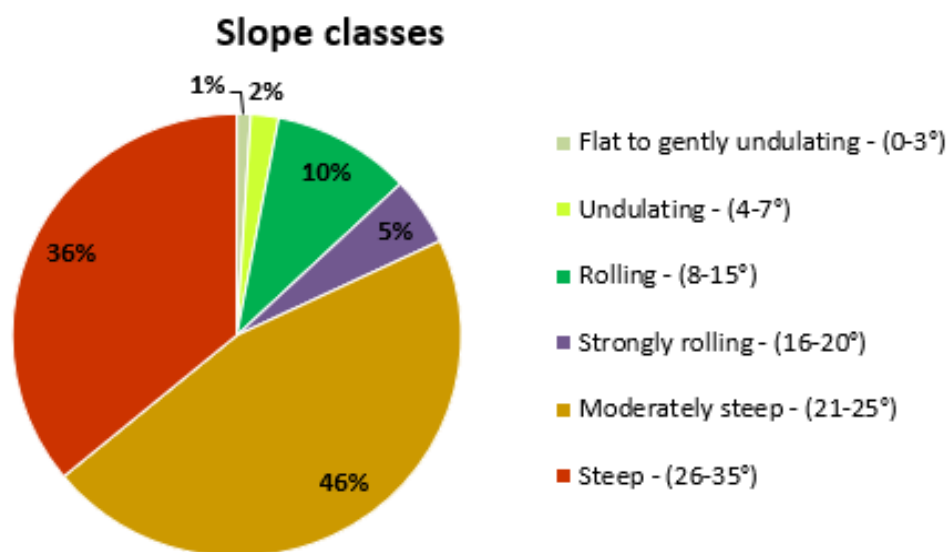
Figure 6. Slope classes within the Aotea Harbour Catchment (from Singleton, 2018).

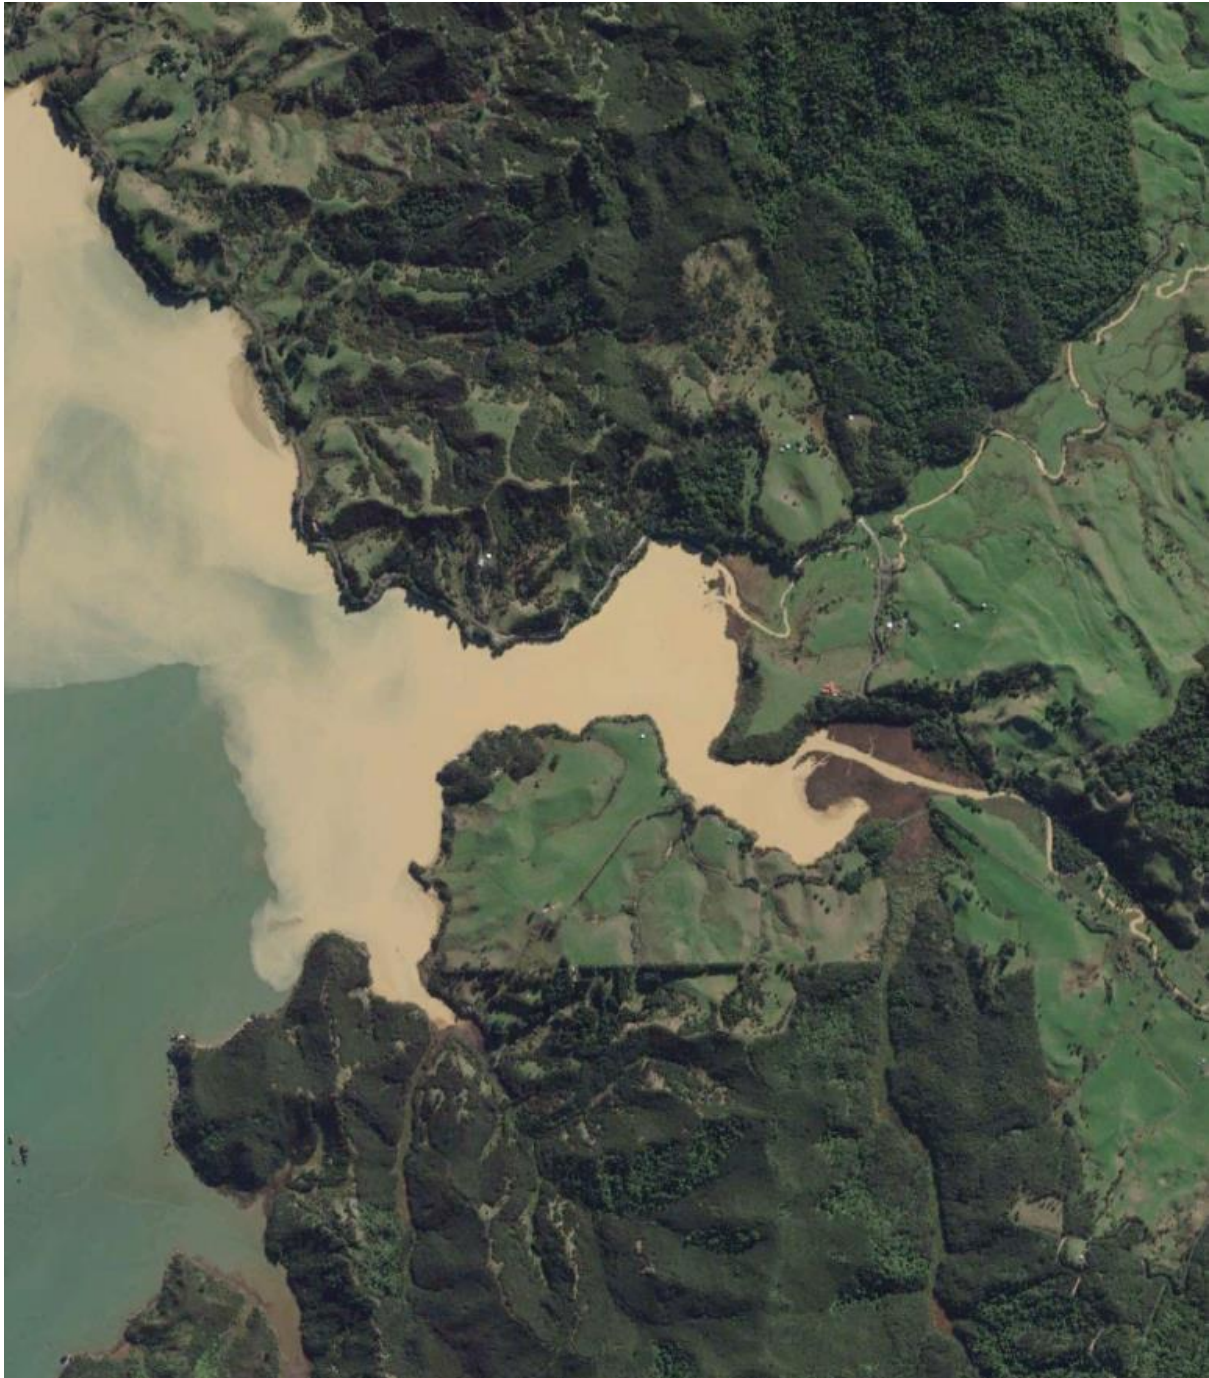
Figure 10. Te Maari and Taparamapua streams discharging sediment into Aotea harbour (Image: Google Earth).

Waikato Regional Council regularly monitors the water quality of 14 streams within the West Coast Zone. There is no monitoring site within the Aotea catchment for water quality and therefore no data. Due to the nature of the Kāwhia and Aotea catchments and their similar topography, land cover, rainfall and land use, it is reasonable to assume that suspended sediment in rivers and streams of these catchments is similar. Turbidity and water clarity in the Kāwhia catchment are variable, generally satisfactory with significantly increased suspended sediment loads during wet weather. An example of high suspended sediment inflow to Aotea Harbour from the catchment (Te Maari and Taparamapua streams) is shown in Figure 10.

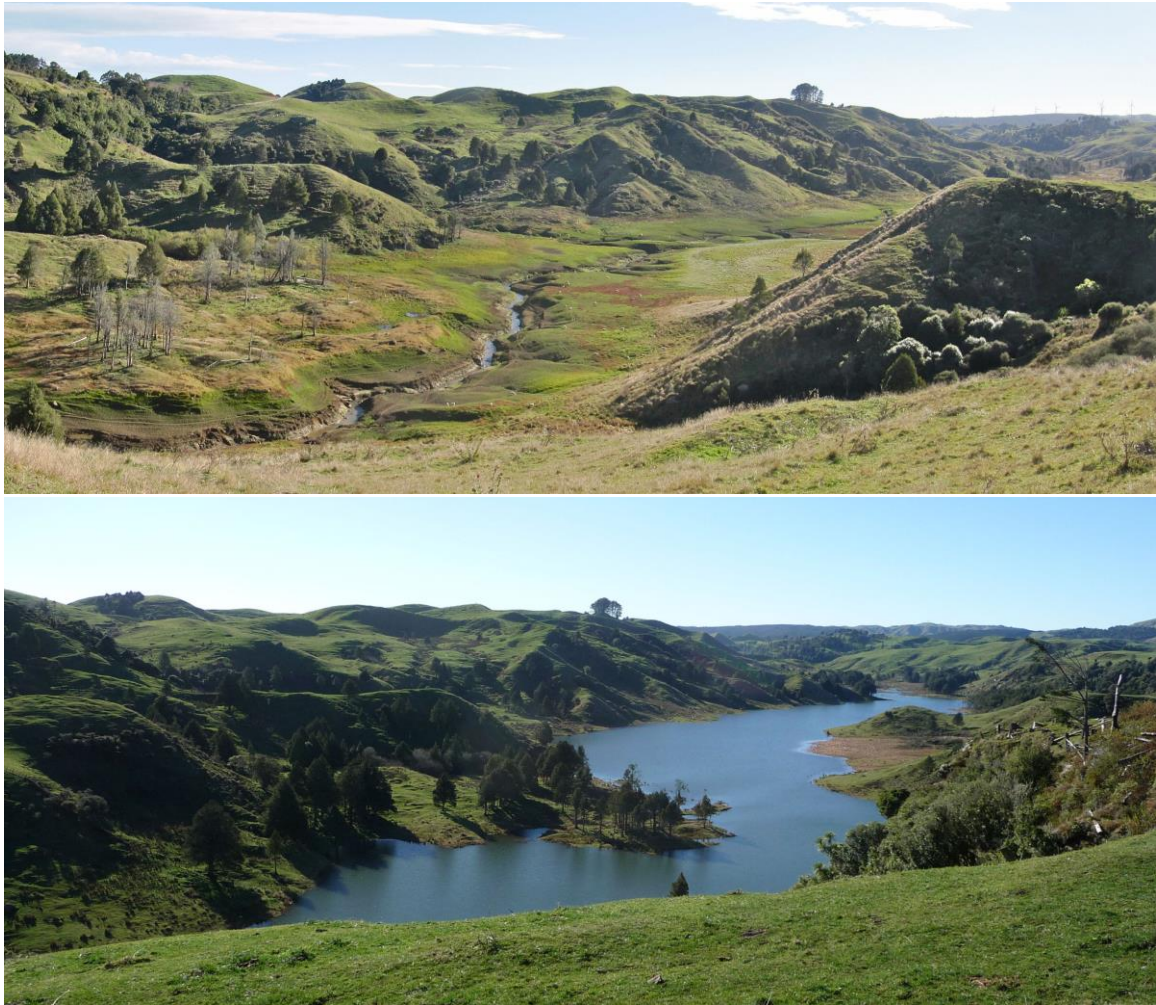
Figure 18. Lake Disappear when empty and full, viewed from Kawhia Rd (July 2008) (Source Wikipedia 2022 [Lake Disappear - Lake Disappear - Wikipedia](#))

Lake Disappear exists in a valley that was once a podocarp forest but is now mostly farmland with some remnant kahikatea and wetland sedges. The lake temporarily fills to a depth of about 15m after heavy rainfall. In such conditions inflows exceed the rate of discharge underground through a limestone sinkhole at the southwest end of the lake. Water reportedly re-emerges in the Pakihi Stream due south, disappears for another 200 metres, then joins Te Maari Stream and finally reaches Aotea Harbour.

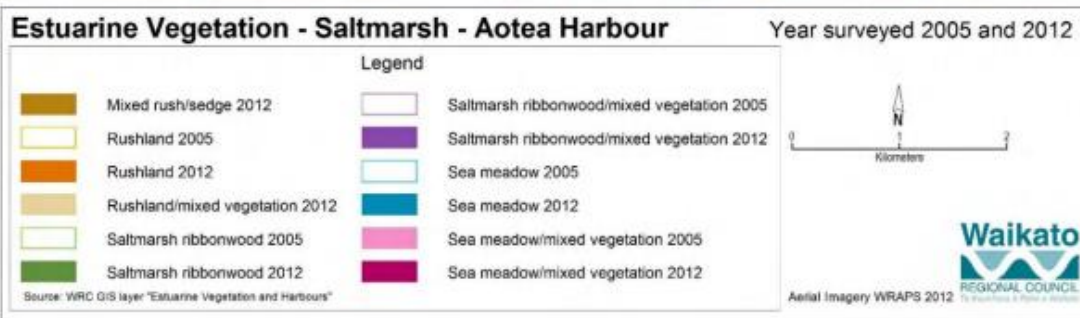
Figure 21. Saltmarsh distribution in Aotea Harbour. Source: Bouma (2016).

The estuarine vegetation of Aotea harbour was surveyed in 2005 and 2012 (Graeme, 2005 and 2014) and a stocktake completed by Bouma in 2016 (Figure 21). The harbour includes mangroves, salt marshes, seagrass, sea meadows and weed communities as discussed below.

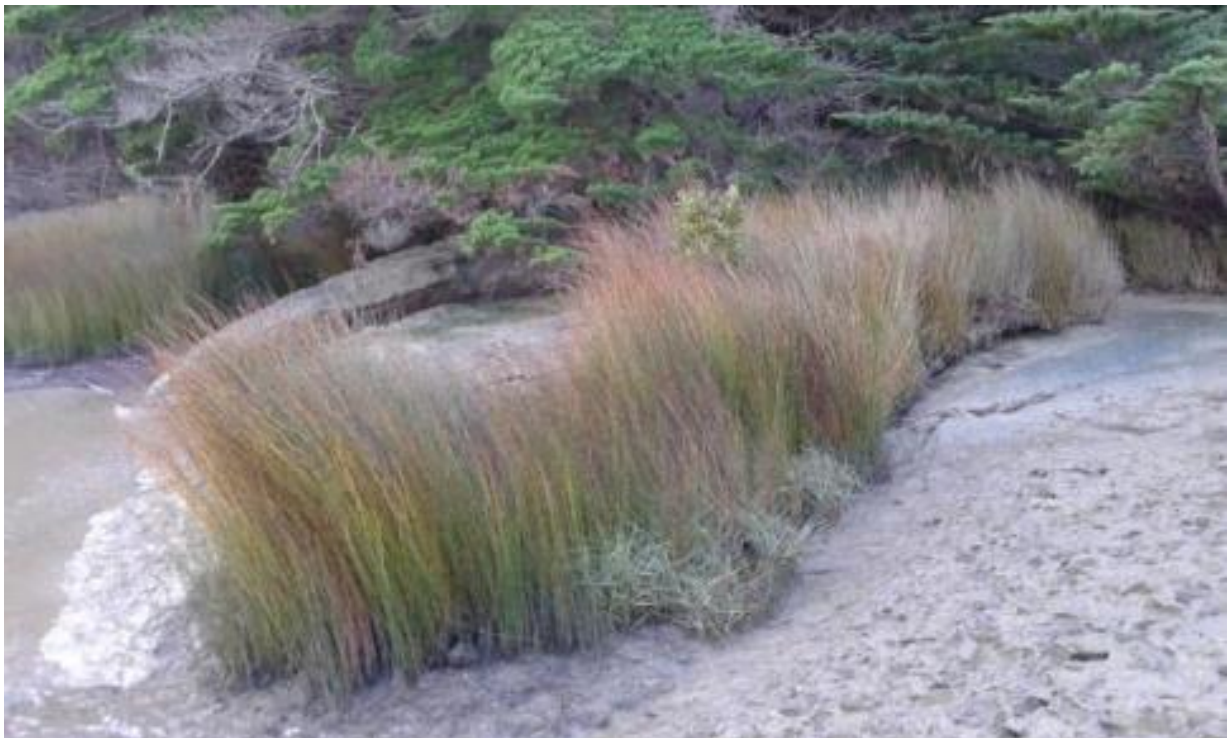
Figure 24. Some short spartina beside a clump of oioi. Also note the mangrove seedling in the oioi. (Graeme, 2014)
