Protecting Waiomu

Flood protection

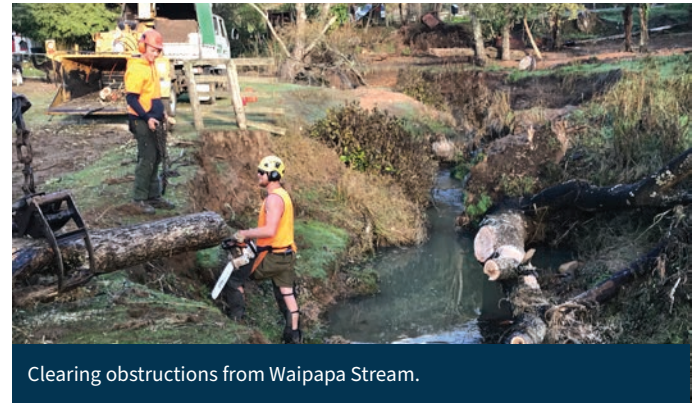
Clearing obstructions from Waipapa Stream.

This exists when a flood event is larger than the scheme is designed to handle, and it could be from debris within the flow or obstructions within the scheme. Obstructions (including walls, buildings, sheds and other structures) in the stream or floodway may result in wider, higher and faster floodwaters, so if you see anything you're unsure about please let us know.
