Protecting Tairua (Grahams Creek)

Flood protection

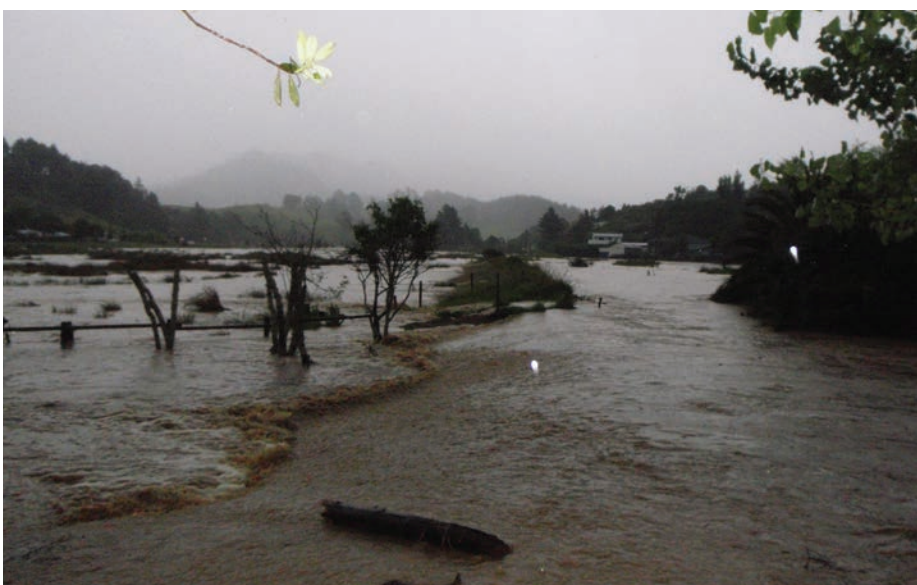
Many properties were subjected to damage and disruption from flood events before the Grahams Creek flood scheme became operational in 2016.

The Grahams Creek catchment, which runs through the town and into the Tairua Harbour, is susceptible to short duration but high intensity rain events causing flash flooding laden with sediment and debris in the streams and surrounding land with little or no warning. The presence of residential dwellings on the low-lying land adjacent to Grahams Stream means that many properties were subjected to damage and disruption from flood events.
